Characterizing and Mitigating Small-Diameter Tool Wear in Nickel-Based Superalloy Machining

MASTER OF ENGINEERING IN ADVANCED MANUFACTURING AND DESIGN

MASSACHUSETTS INSTITUTE OF TECHNOLOGY

August 2025

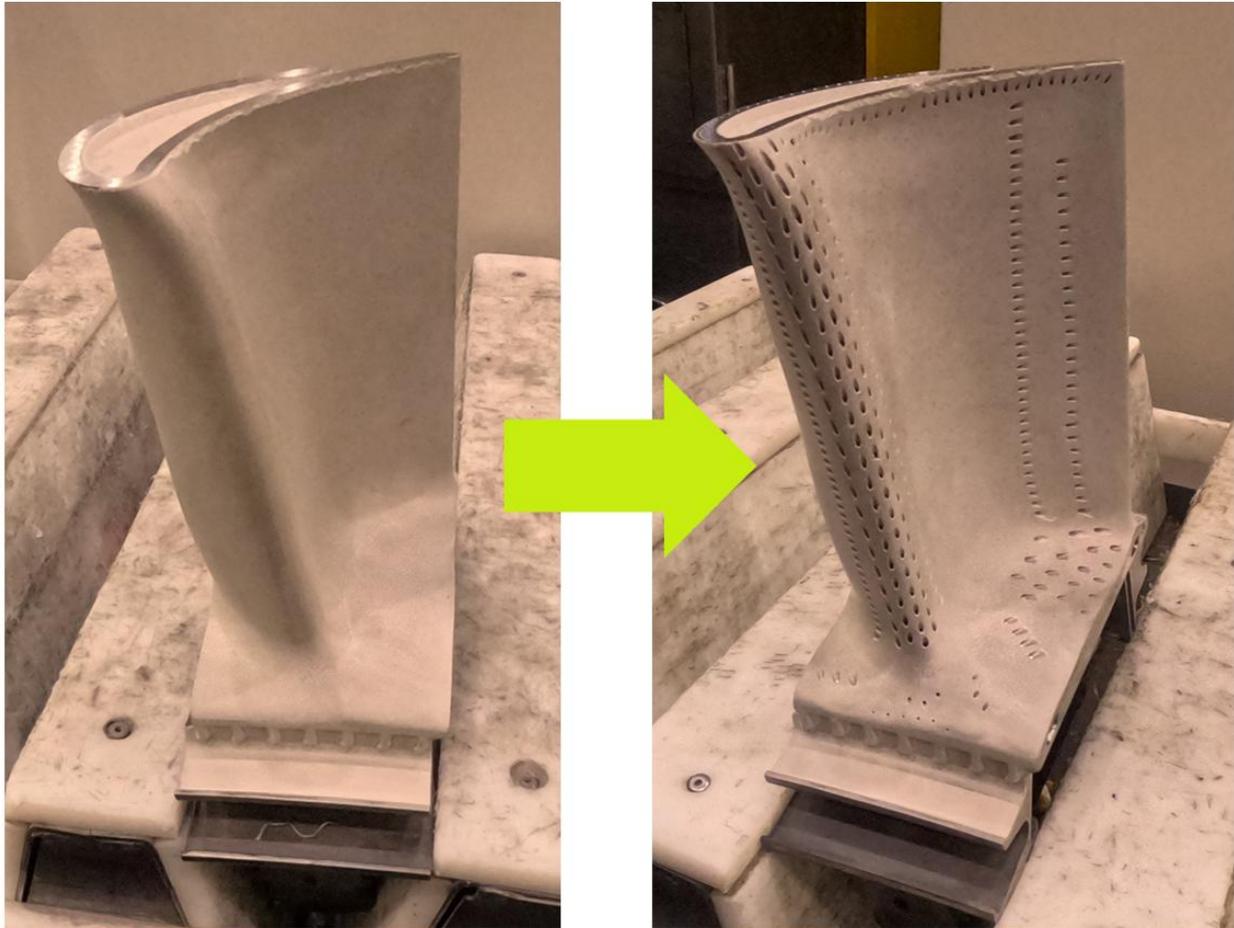
Figure 1.1: Turbine blade before (left) and after (right) the hole milling process.

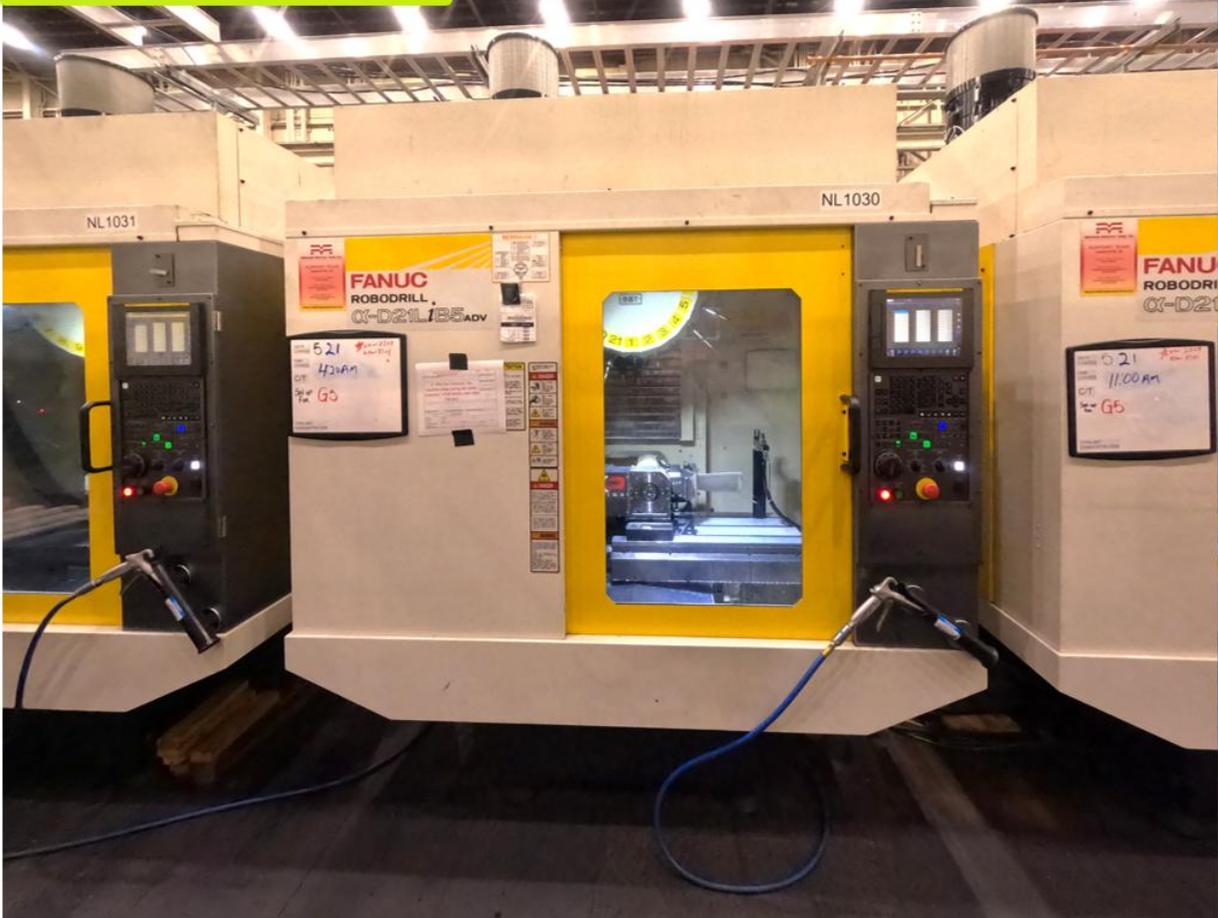
Figure 1.2: Drill through coating (DTC) RoboDrill machine line.

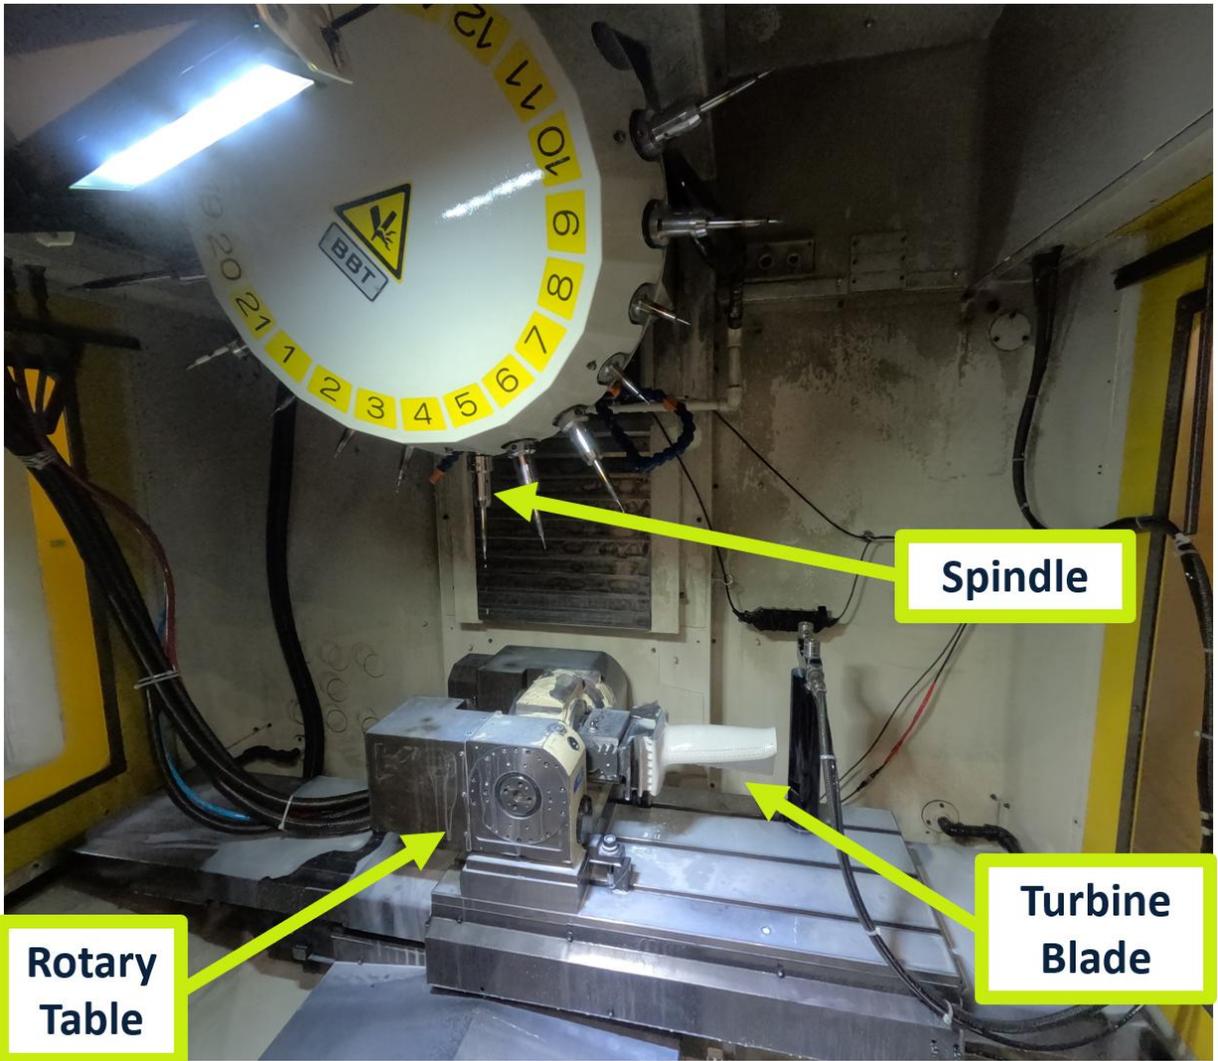
Figure 1.3: Rotary table holding turbine blade inside RoboDrill.

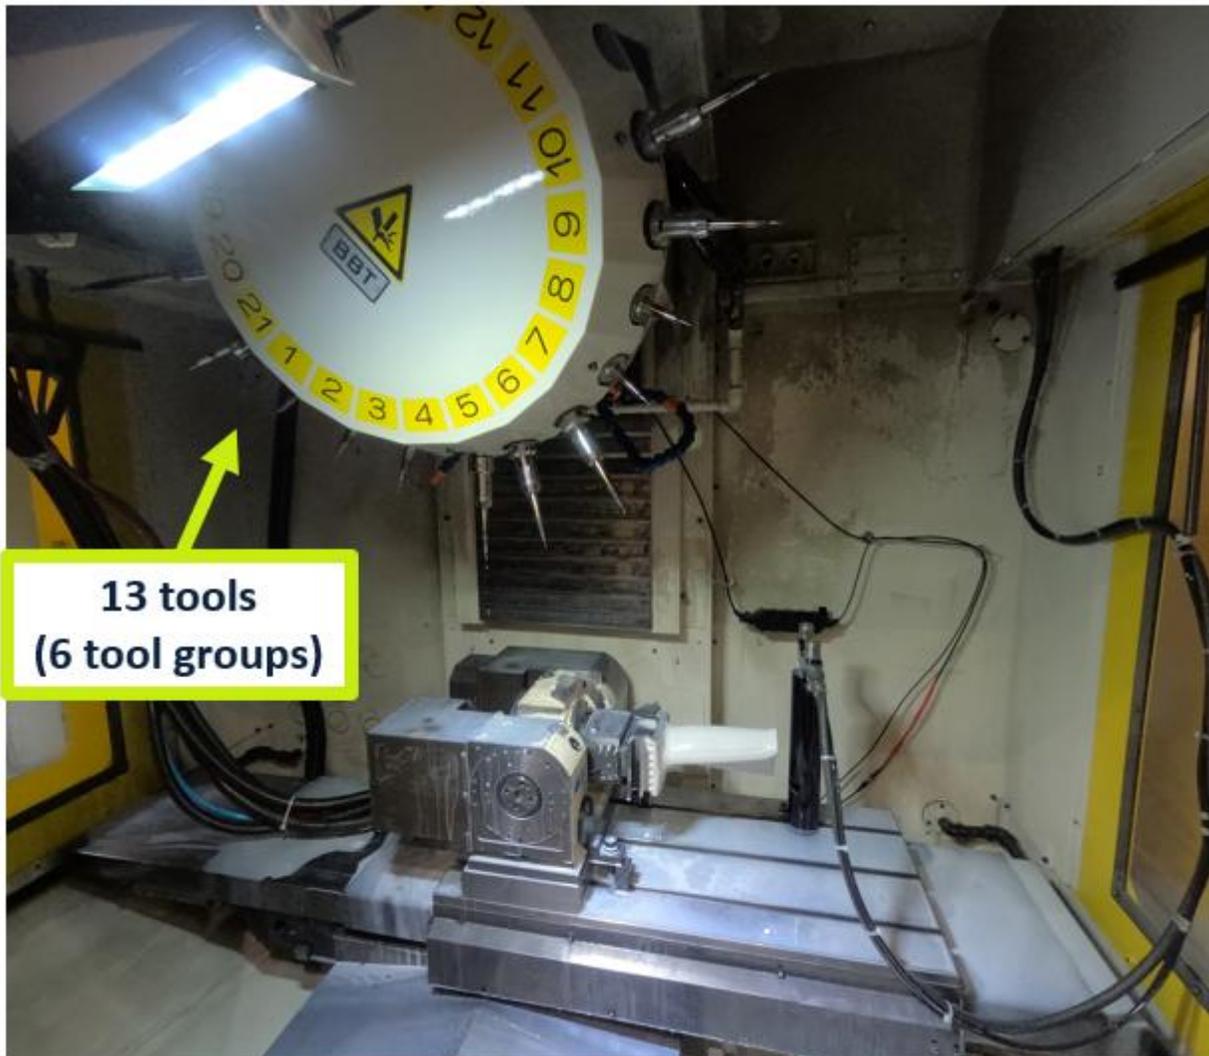
Figure 2.1: 13 tools held in RoboDrill turret for use during operation. The turret holds multiple of each type of tool to use when a tool breaks.

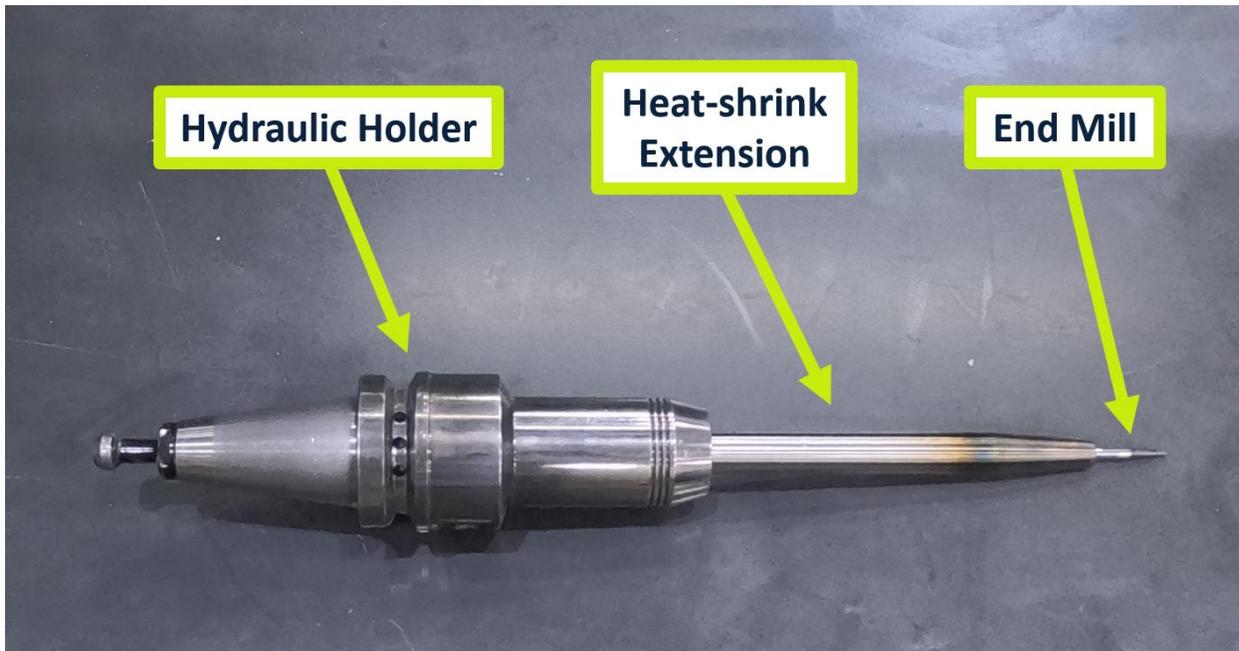
Figure 2.2: Long length tool holder setup.

2.3 shows each piece of the tool holder setup separated, and Figure 2.4 shows the three lengths of heat-shrink extension that are used in operation.

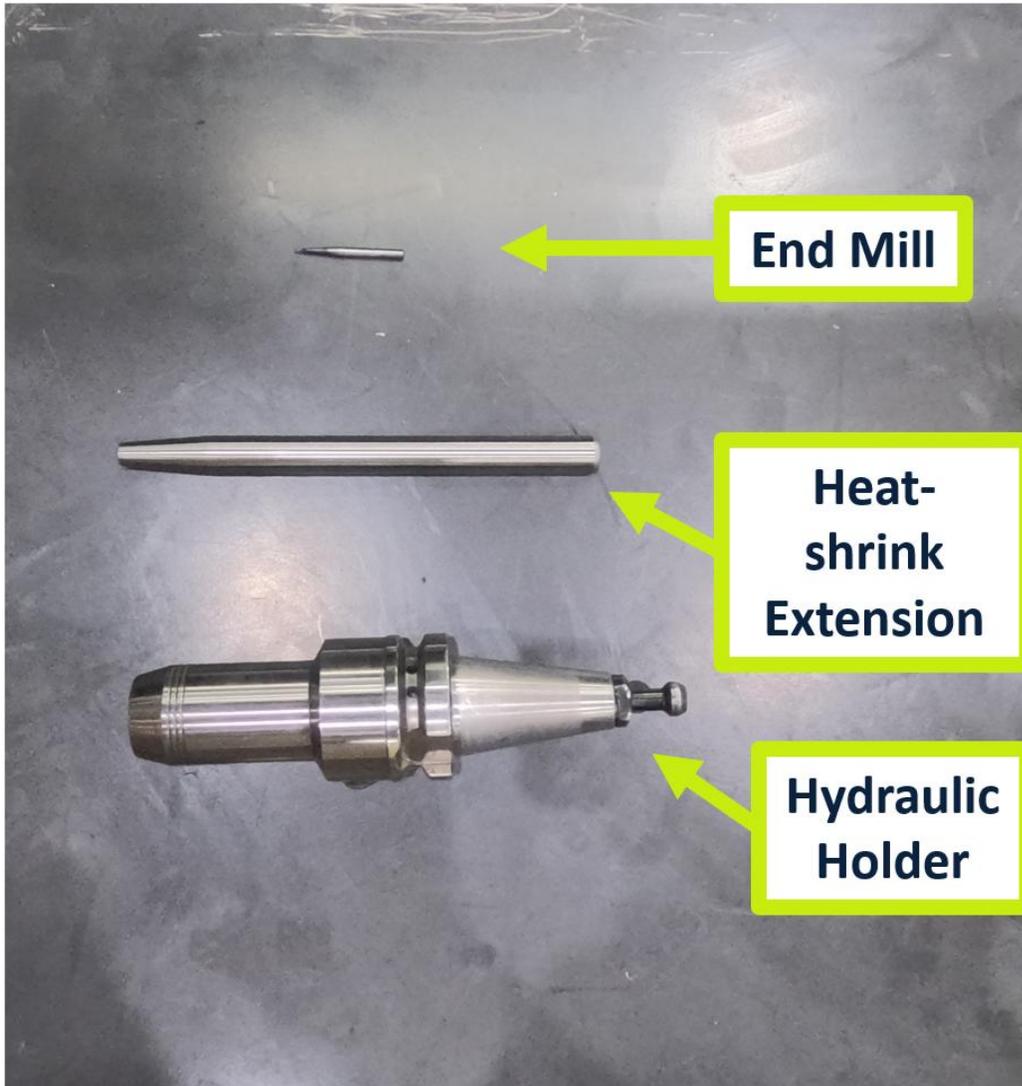
Figure 2.3: Long length tool holder separated into components.

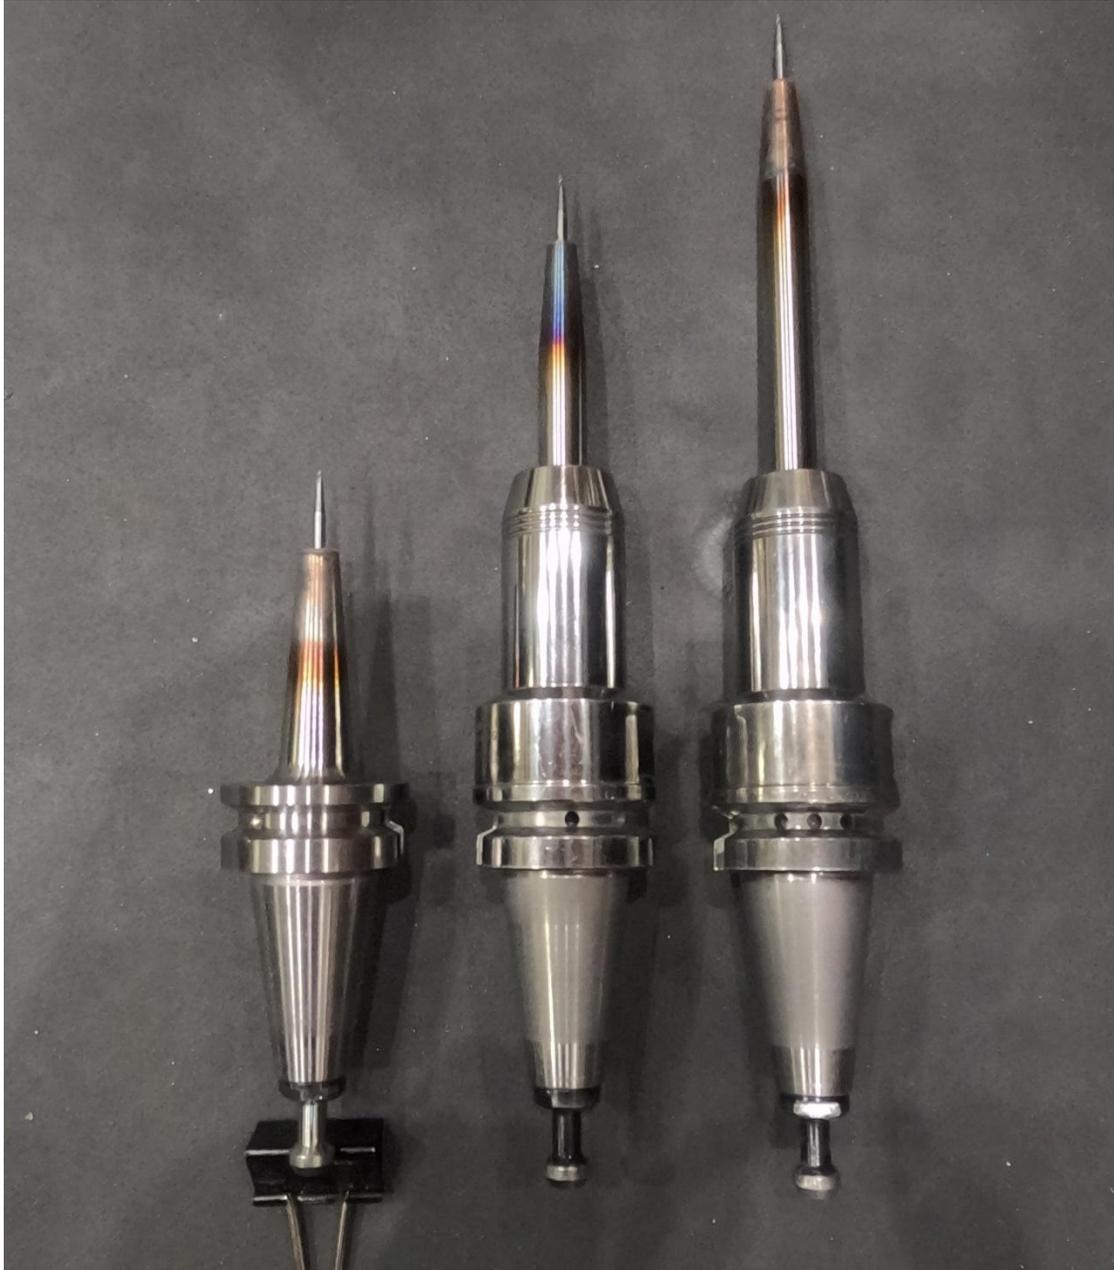
Figure 2.4: Three lengths of heat shrink holders (large, medium, and small).

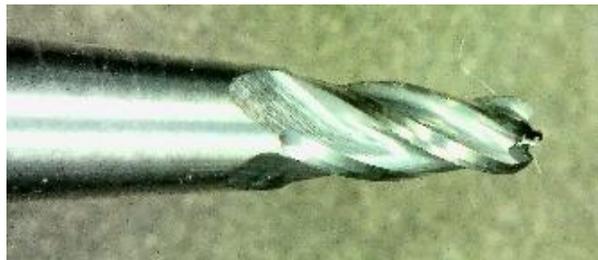
To provide a reference, a new roughing end mill was photographed from orthogonal perspectives. Figure 2.5 shows that two flutes do not converge at the tip of the tool. Figure 2.6 shows the same tool as Figure 2.5, with the tool rotated 90° along the center axis to highlight the two flutes that do converge at the tip. The well-defined cutting edges in these images serve as a strong comparison point for assessing broken tools.

Figure 2.5: New roughing end mill showing the tips of each flute.

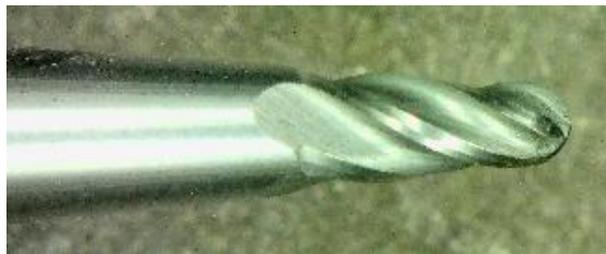
Figure 2.6: New roughing end mill rotated 90° to display a clean center point.

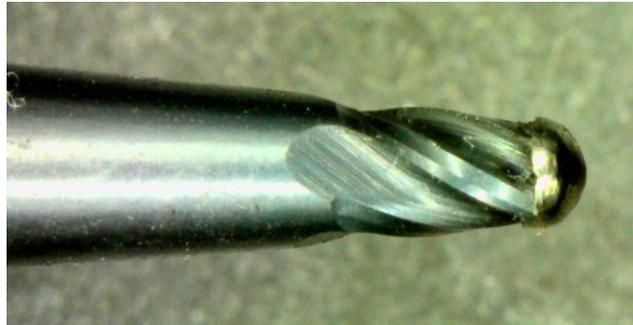
In the melted tool image, Figure 2.7, a gloss, darkened appearance can be seen near the cutting end, likely indicating thermal overload. This may have resulted from ineffective chip evacuation or localized heat accumulation due to poor coolant flow or excessive engagement time. Localized high temperatures are expected due to the thermal conductivity of both the superalloy and the ceramic coating. While this tool appears melted, it is possible that it shattered before melting, due to how much of the tool is missing. This is apparent when comparing with Figure 2.5 and Figure 2.6, new end mills.

Figure 2.7: Broken roughing end mill with evidence of thermal degradation.

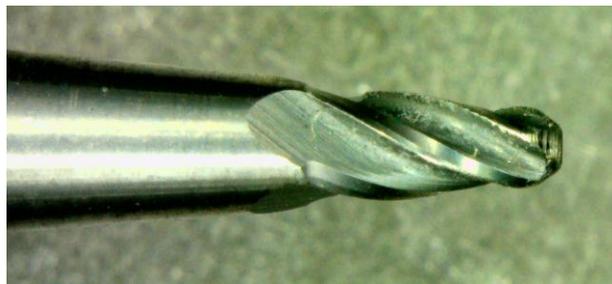
The dull tool shows worn flute edges that appear blunt and smooth. This visual signature aligns with flank wear and edge rounding often seen during tool aging, particularly in difficult-to-machine materials such as coated superalloys. The absence of clear cutting edges suggests that this tool was used after it exceeded its effective cutting life. Using a dull tool can amplify heat buildup and chatter, leading to more catastrophic forms of breakage

Figure 2.8: Worn roughing end mill with edge dulling.

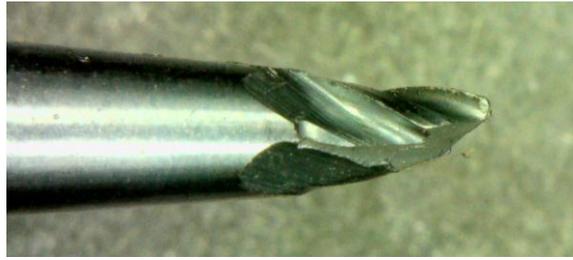
The shattered example has sharp fractured surfaces and a large portion of the tool missing. This type of failure is typical of mechanical overload or vibrational instability and may have been caused by several suboptimal cutting parameters resulting in excessive force against the end mill during operation. Shattering failures often occur abruptly and without warning signs seen in gradual wear modes.

Figure 2.9: Catastrophically fractured roughing end mill.

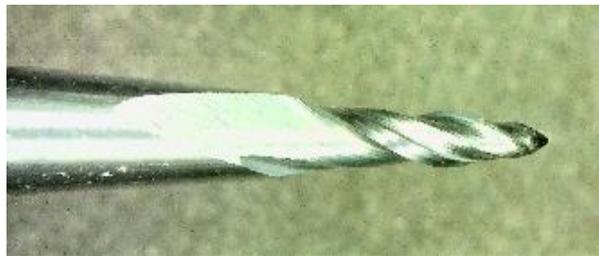
As with the larger tools, two new finishing tools were documented. Figure 2.10 shows a new finishing end mill with a sharp tip. Rotated 90°, Figure 2.11 presents a rounded appearance, showcasing the two flutes meeting at the center axis of the tool. Comparing the sharpness of the tip and flutes in these photographs emphasizes the failure modes displayed in further photos.

Figure 2.10: New finishing end mill showing sharp tip geometry.

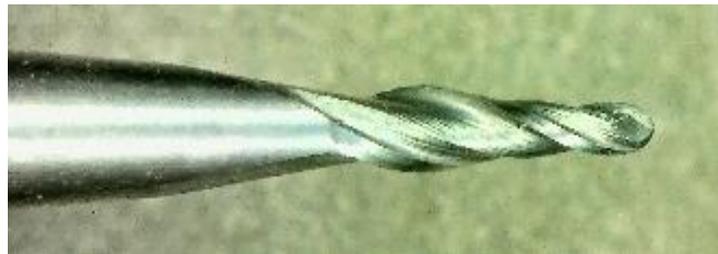
Figure 2.11: New finishing end mill rotated 90° to display flute convergence.

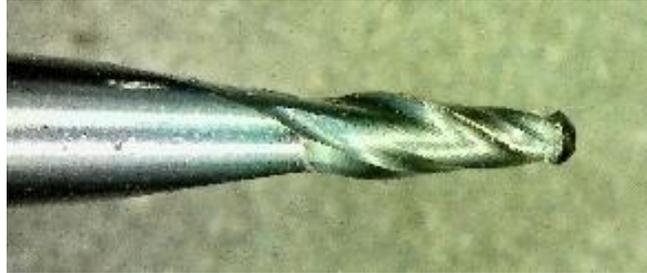
The melted finishing tool shows evidence of thermal degradation concentrated around the tip of the tool. This rounded tip exceeds the profile of the taper in the tool, confirming melting. Of the observed tools, this failure type is far less common in the finishing tools compared to the roughing tools.

Figure 2.12: Broken finishing end mill with evidence of thermal degradation.

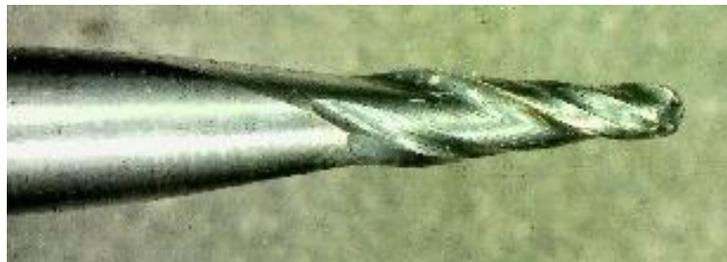
The failure in Figure 2.13 is more difficult to see than the other failure modes because it is less drastic in terms of material removed or deformed on the tool. The failure in this tool is an optimal failure, because the tool has been used for its effective life, without being over-used or having the effective life cut short.

Figure 2.13: Worn finishing end mill with edge dulling.

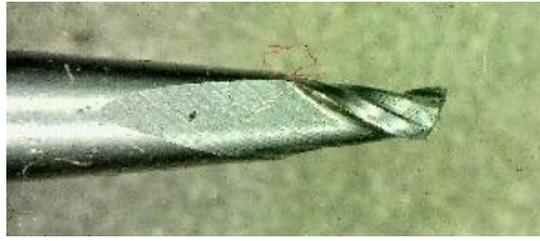
The shattered finishing tool, much like its roughing counterpart, displays abrupt fracture, which may have been caused by several process parameters. The smaller diameter and higher aspect ratio make these tools especially vulnerable to brittle failure. Within the sample of broken finishing tools collected, most of the failures were characterized as shattering.

Figure 2.14: Catastrophically fractured finishing end mill.

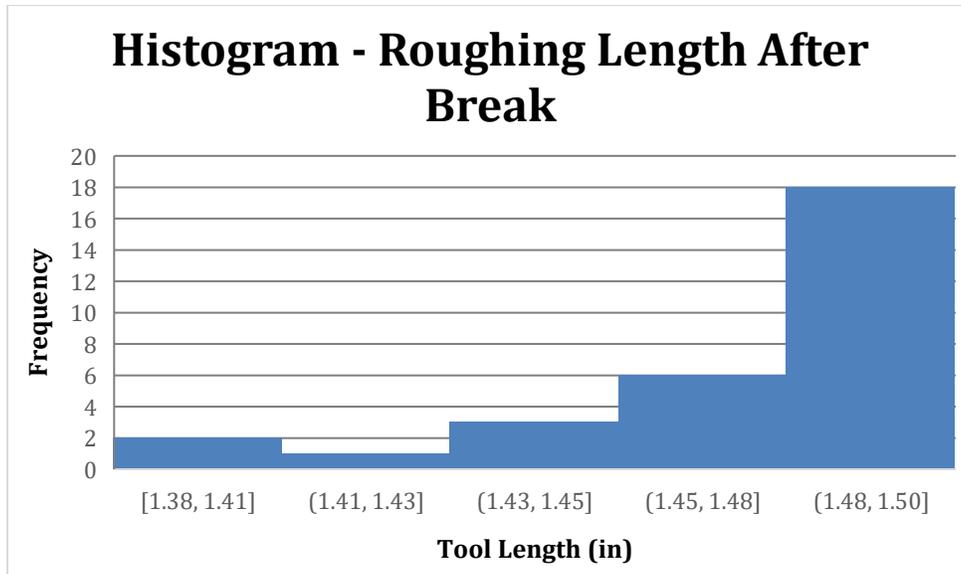
Figure 2.15 presents a histogram of the post-failure lengths of all roughing tools photographed. Although the exact starting length of each tool is unknown, a distribution of new tool lengths was used to estimate a nominal baseline. For roughing tools, the average new tool length was 1.5027 inches, with a standard deviation of 0.00218 inches. When a RoboDrill flags a tool as broken, it checks if the tool is within 0.008 inches of the starting length. The histogram shows a strong leftward skew, with the most frequent tool breakage bin being around eight thousandths of an inch of the average new tool length. This pattern suggests that the roughing tools are failing due to standard wear and not breakage.

Figure 2.15: Histogram of tool lengths for broken roughing end mills.

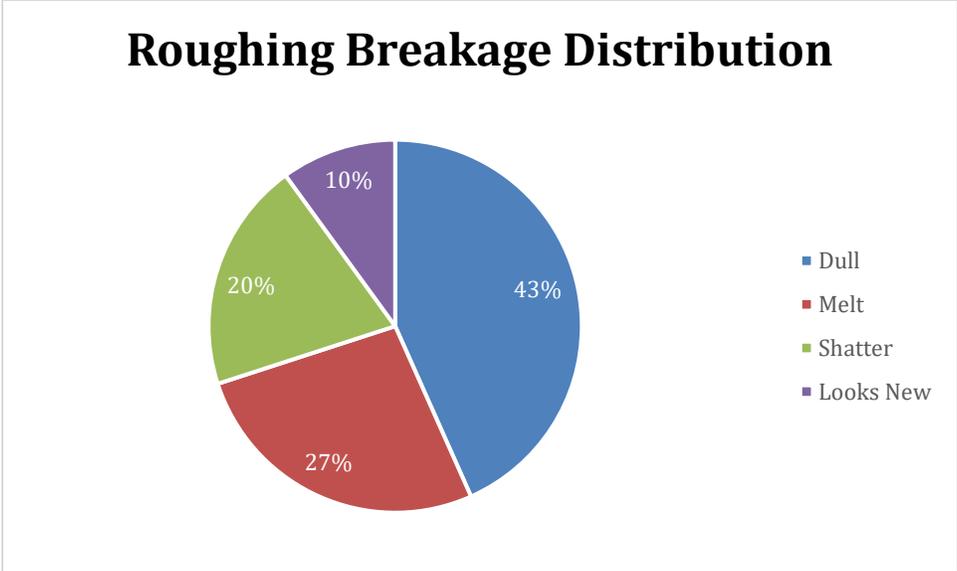
The appearance of tools that look new at the time of disposal may seem noteworthy, because they appear to be tools that are discarded prematurely. However, observation of the RoboDrill operators showed that operators dispose of tools due to caution in ambiguous situations, such as if the tool accidentally hits the ceiling of the buffer container when placed, or if the tool does not sit correctly in the heat shrink holder.

Figure 2.16: Pie chart of breakage types for broken roughing end mills.

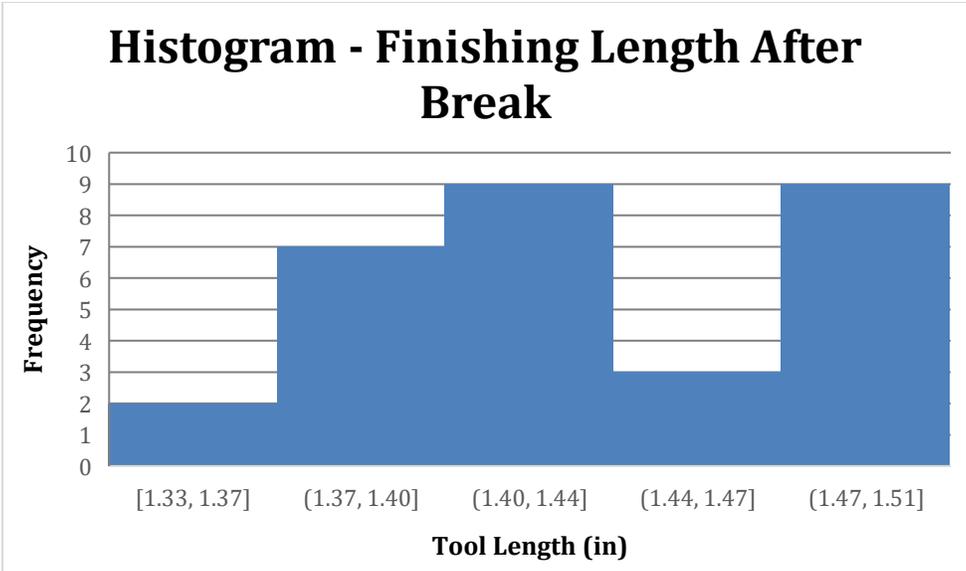
The results for finishing tools, shown in Figure 2.17 and Figure 2.18 paint a different picture compared to roughing tools. The average measured length of new finishing tools was 1.5000 inches, with a standard deviation of 0.00202 inches. Figure 2.17 shows a bimodal histogram of tool lengths following failure. One cluster of tools is grouped near the expected failure length at the far right of the histogram, while the second cluster is significantly lower in length. At first glance this may suggest the balanced existence of dulling and melting or shattering as the main failure modes, but the greater number of tools distributed in the lower range of lengths indicates a strong presence of catastrophic breakage.

Figure 2.17: Histogram of tool lengths for broken finishing end mills.

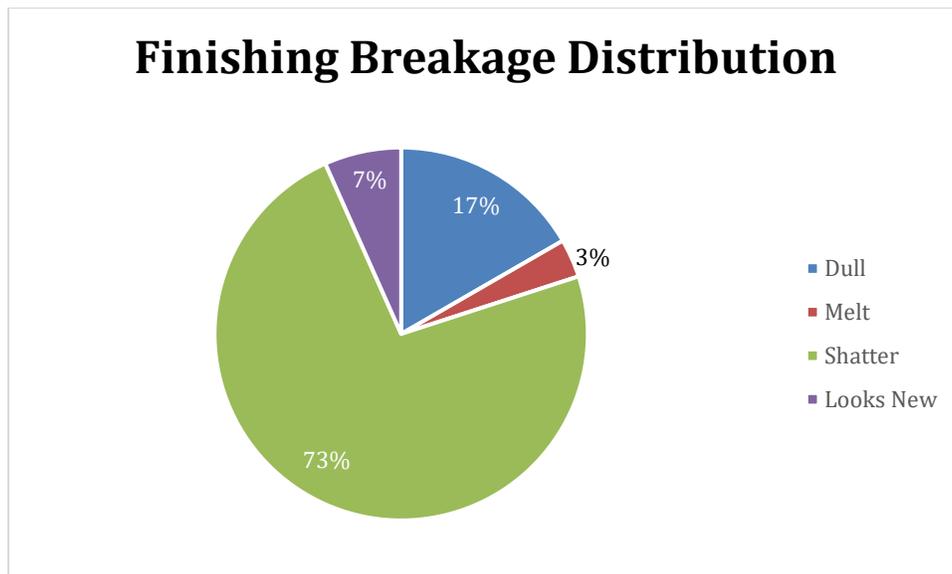
This interpretation is supported by the pie chart in Figure 2.18, which shows that shattering accounts for approximately 73% of all failures for the random selection of finishing tools analyzed. It is interesting to note that the location where the tool shatters is inconsistent, with some tools shattering near the tip and others shattering much further up the tool (Appendix A has the measured lengths of all the tools with their images for reference). The two other minor categories of breakage are tools that melt and those that appear visually new. Interestingly, tools that are visually indistinguishable from new tools were more frequent than those that melted, contrary to the pattern observed in the roughing tools.

Figure 2.18: Pie chart of breakage types for broken finishing end mills.

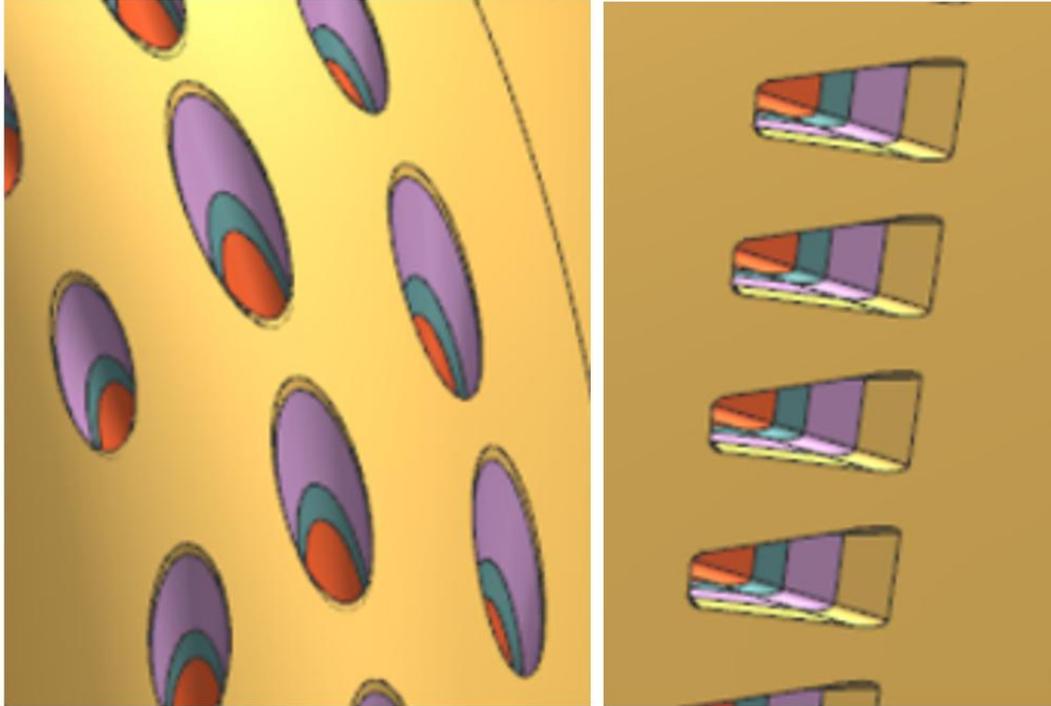
Figure 3.1: Two different diffuser hole shapes: circle (left) and rectangle (right).

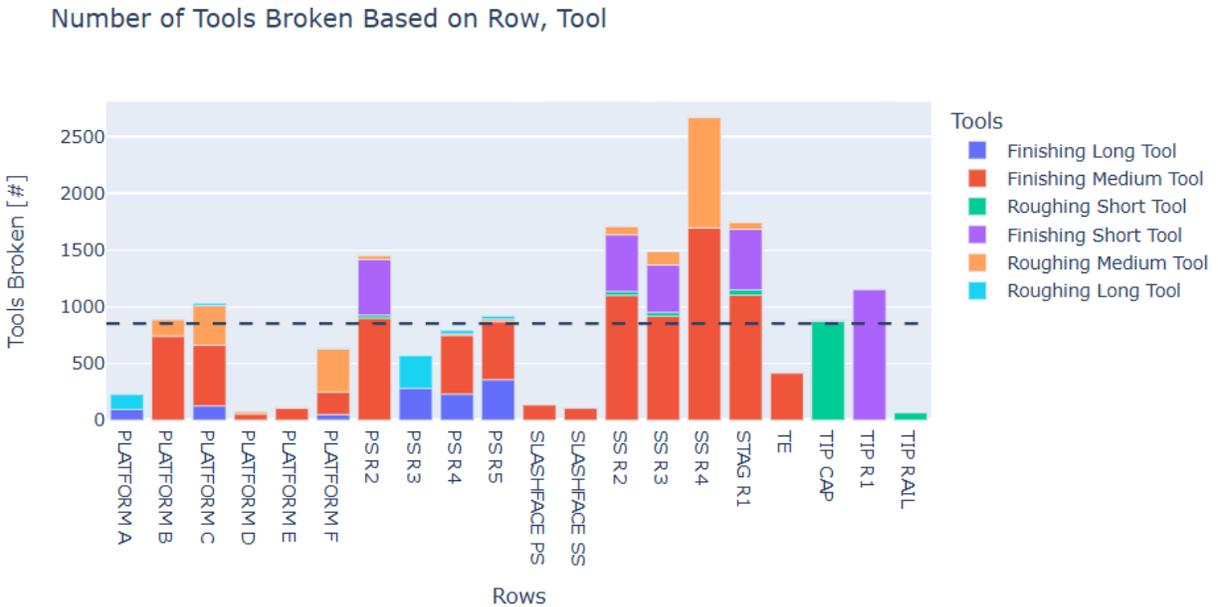
Row 2. Comparing these rows to Table 3.1 which summarizes row geometries, it is noted that all four of these rows have circular profiles. Also, all four of these rows are near one another on the leading edge of the blade. This correlation suggests that hole geometry or blade location may be a significant factor influencing tool failure. Furthermore, while rows with fewer holes would intuitively be expected to cause fewer breaks, this trend is not consistent. The elevated failure rates seen in rows with comparable holes indicate that geometry and other process variables are likely greatly influencing tool life.

Figure 3.2: Bar chart of total tool breakage by row, segmented by tool type.

To further refine the understanding of failure patterns, Figure 3.5, much like Figure 3.2, once again plots tool breakage across rows, but this time separates each bar by hole number. This visualization uncovered two holes with significantly elevated failure rates compared to others. This chart sparked an investigation into the programming of Platform B Hole 4 and Platform C Hole 11. This chart shows separate hole entries for roughing and finishing operations, and therefore it is known that both problematic holes are causing the finishing tool to break.

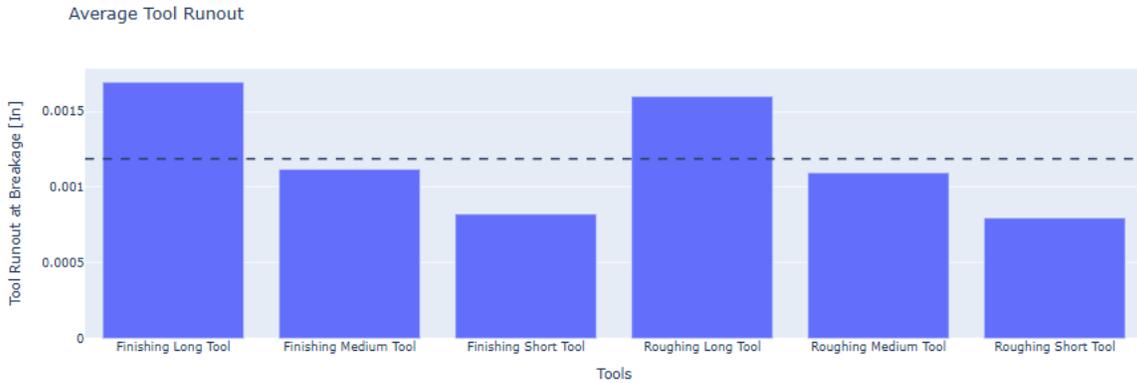
To evaluate the potential influence of tool concentricity on these failures, Figure 3.3 illustrates the average runout for each tool type. As expected, longer tools exhibit greater average runout due to increased deflection and geometric sensitivity. The longest finishing tools show a marked increase in runout compared to their shorter counterparts. It is important to note that runout is only measured when a new tool is mounted in the machine. In-process runout is not captured due to the time cost of measuring after each operation.

Figure 3.3: Bar chart of average runout by tool type.

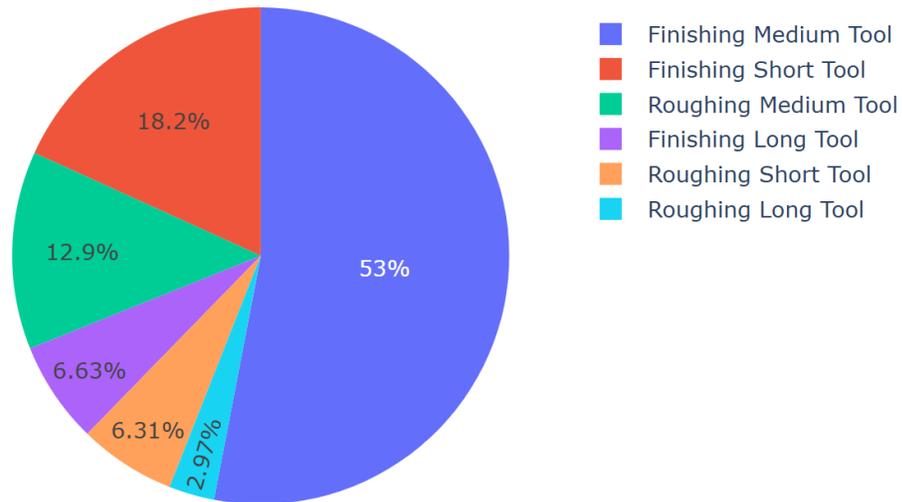
Figure 3.4: Pie chart showing tool breakage distribution by tool type.

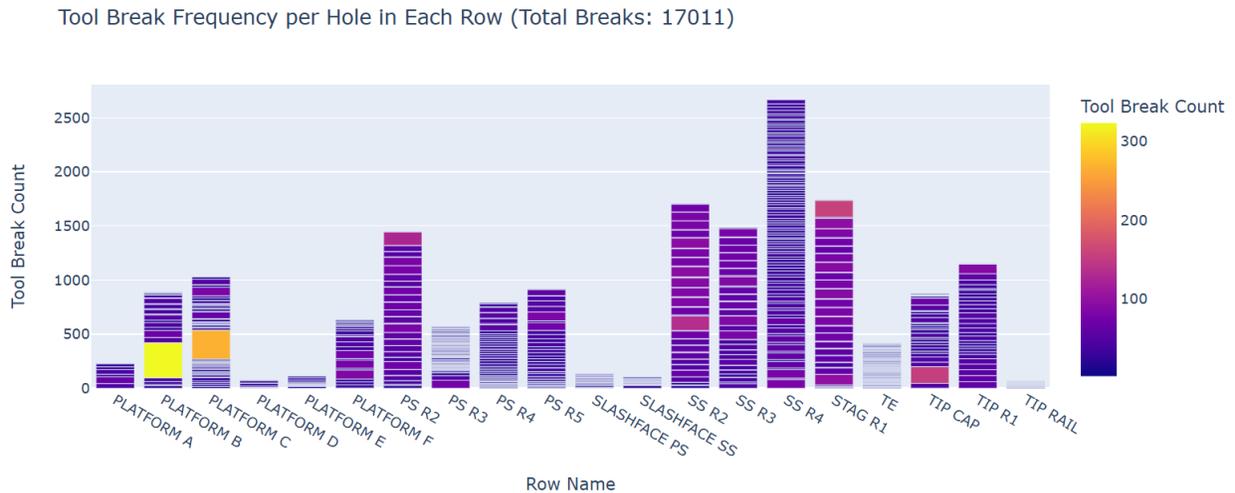
Figure 3.5: Bar chart of total tool breakage by row, segmented by hole.

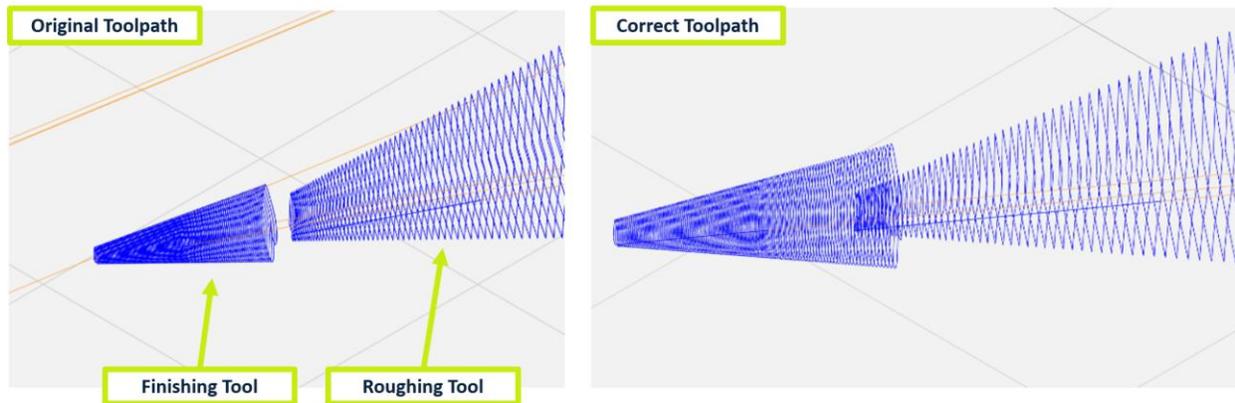
It was discovered that both holes had significant programming errors. For CAM programming, a toolpath is provided to the RoboDrills. This path is a helix shape that the RoboDrills follow to machine a hole. In each toolpath, the tip of the tool follows the path; this results in the finishing tool requiring a larger diameter path to match the outer surface of the hole cut by the roughing tool. For Platform C Hole 11, the initial program lacked overlap between the roughing and finishing operations. Figure 3.6 illustrates the original and corrected toolpaths. Because of this gap between the toolpaths for each tool, the machine would plunge the finishing tool directly into solid metal before attempting to cut, shattering the tool. The correct toolpath, shown on the right, has an overlap between the roughing and finishing path so that the finishing tool would start spinning a bit before it encountered the metal. Additionally, because tools are not remeasured after each hole, it is never known where the roughing pass ended exactly. The bottom face of the hole could be within eight thousandths of an inch of where it is programmed to be because the tool is not flagged as broken until it wears past that point. Because of this, the overlap between the roughing and finishing pass needs to be at least 0.008 inches. This issue had gone unnoticed in production because the RoboDrill was programmed to skip a hole after two consecutive tool failures. This prevented further failures but masked the underlying problem. Once identified, the program was updated to properly overlap the two paths.

Figure 3.6: CAM toolpath comparison for Platform C Hole 11.

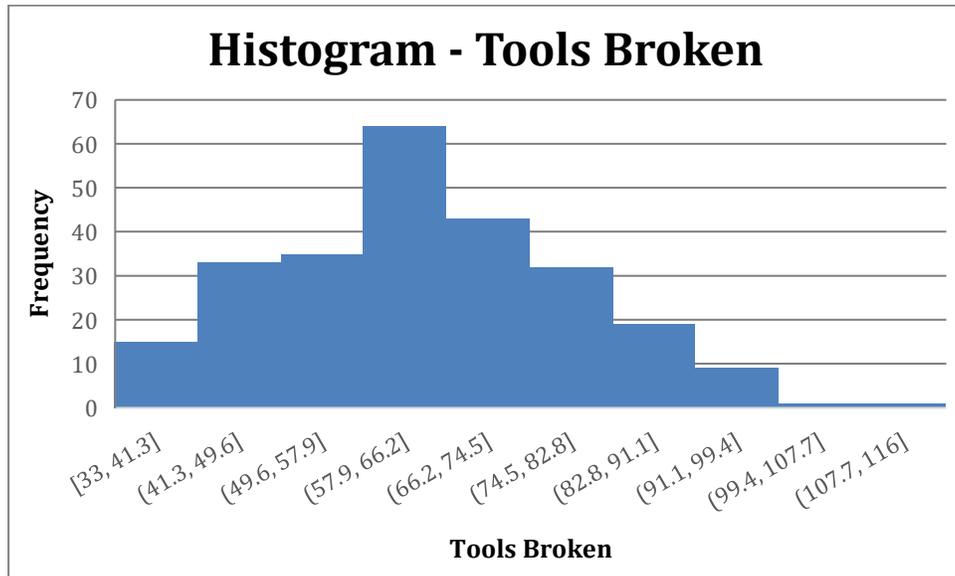
Figure 3.7: Histogram of tools broken per part.

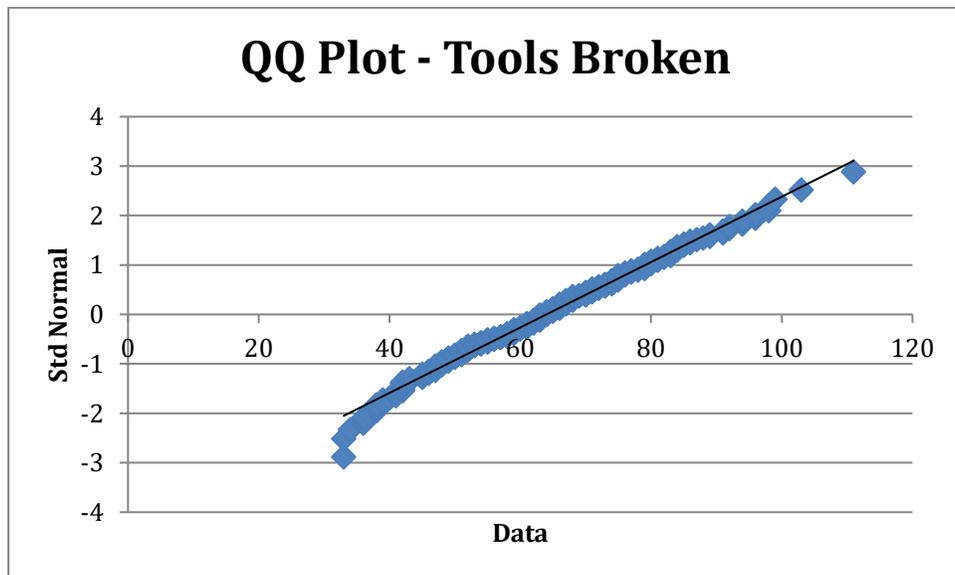
are the dataset, and the line is a perfectly normal distribution. The dataset closely follows a normal distribution, which supports the use of ANOVA. It is important to note that machines NL1030 and NL1031 have fewer than ten historical data logs and therefore they were omitted from this analysis.

Figure 3.8: Q-Q plot of tools broken per part. This plot implies normal behavior because of the linearity of the data.

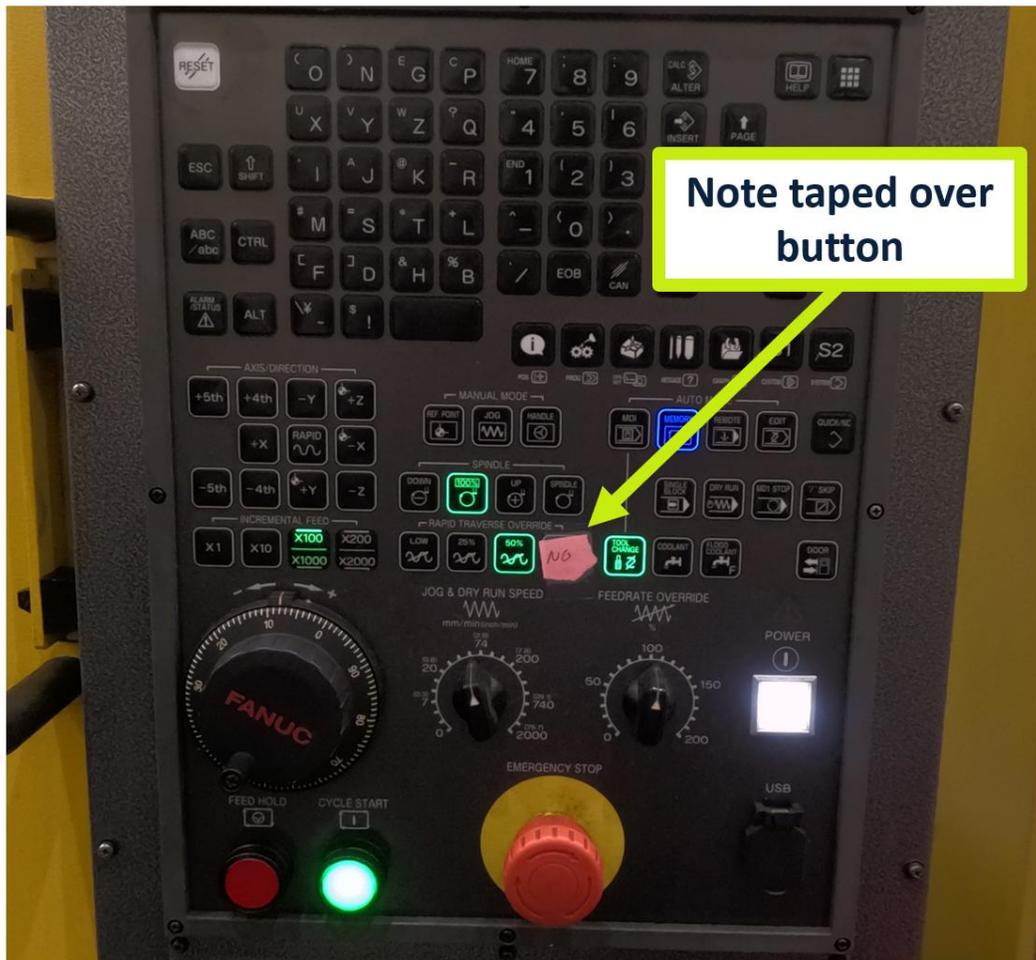
To investigate possible root causes, historical maintenance logs were reviewed for all machines. Surprisingly, no clear correlations emerged between recorded maintenance events and tool breakage rates. However, an observation on the factory floor revealed a critical issue with NL1024 that was not documented in the maintenance logs. As seen in Figure 3.9, a small note affixed to the machine instructed operators to avoid using 100% rapid traverse speeds. Rapid traverse refers to the machine's high-speed, non-cutting movements between holes or tool changes. An engineer revealed that at full speed the rotary table would fault the machine. The rotary table does not move during hole milling, it only moves between holes to align the part with the spindle, and therefore all its movements are in rapid traverse mode.

Figure 3.9: A note on NL1024 hiding the 100% rapid traverse override button.

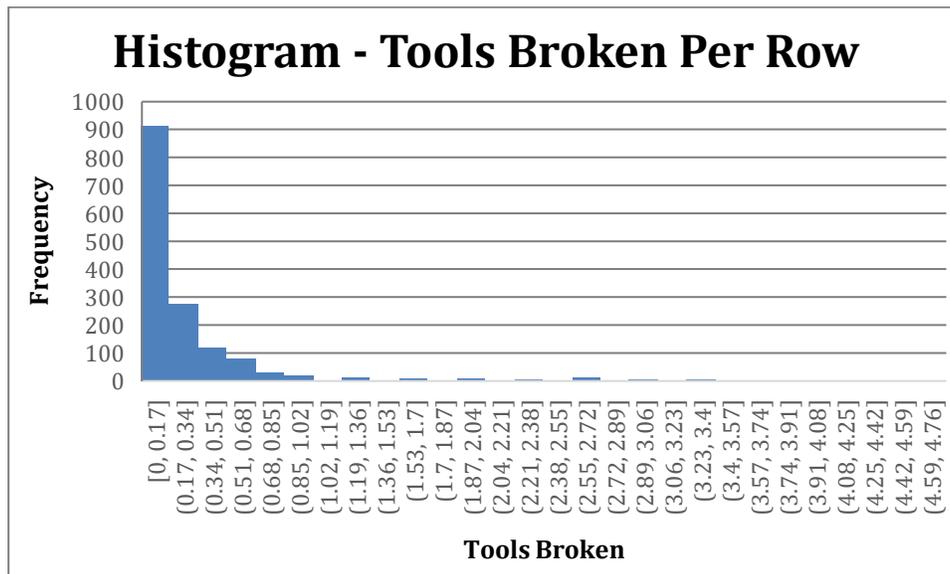
Upon graphing this normalized data, the data was shown to be exponentially distributed as opposed to normally distributed. This can be seen in Figure 3.10. This violates a key assumption of the ANOVA test, which requires normally distributed data. To address this, a Kruskal-Wallis test was performed instead. The Kruskal-Wallis test is a non-parametric alternative to ANOVA that works by assessing whether the median across groups is different as opposed to means. Similar to one-way ANOVA, the goal of this test is to provide a statistical confidence level that groups originated from the same statistical distribution.

Figure 3.10: Histogram of tools broken per row, normalized by number of holes per row. Each bin contains data, although difficult to see due to the exponential distribution.

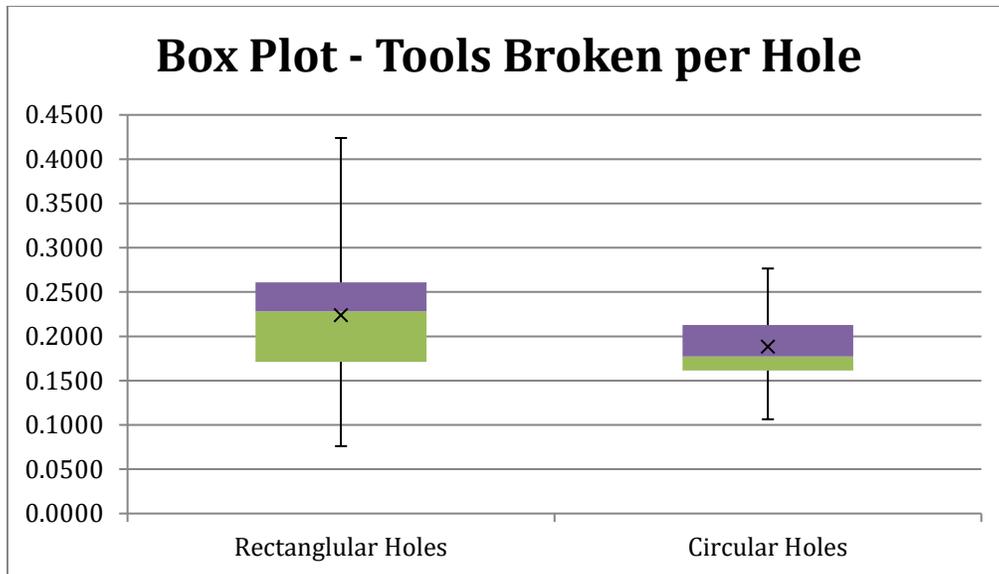
To account for the differences in the number of holes across rows, the dataset was normalized by dividing the total number of tools broken per group by the total number of holes in the collective rows. A box plot to visualize this data can be found in Figure 3.11. Initial inspection of the data through Q-Q plots, as seen in Figure 3.12 and Figure 3.13, suggested that both datasets were approximately normally distributed, although slight deviations were observed in the plot for the circular holes. To further validate normality, Shapiro-Wilk and d'Agostino-Pearson tests were performed, both confirming normality at a 95% confidence level.

Figure 3.11: Box plot of tools broken by hole, segmented by hole profile and normalized by hole count.
