Characterizing and Mitigating Small-Diameter Tool Wear in Nickel-Based Superalloy Machining

MASTER OF ENGINEERING IN ADVANCED MANUFACTURING AND DESIGN

MASSACHUSETTS INSTITUTE OF TECHNOLOGY

August 2025

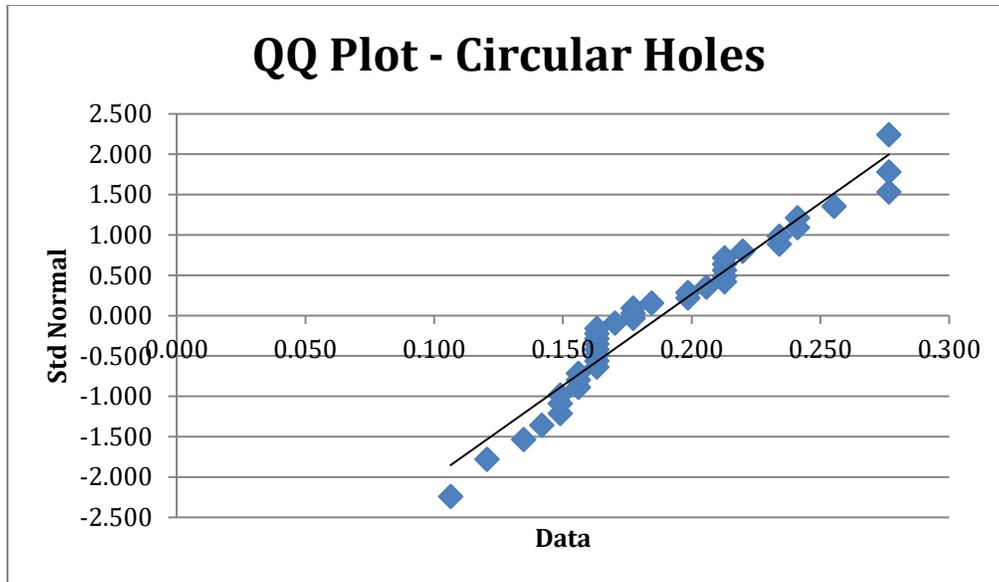
Figure 3.12: Q-Q plot of tools broken per select rows with circular holes. This plot implies normal behavior because of the linearity of the data.

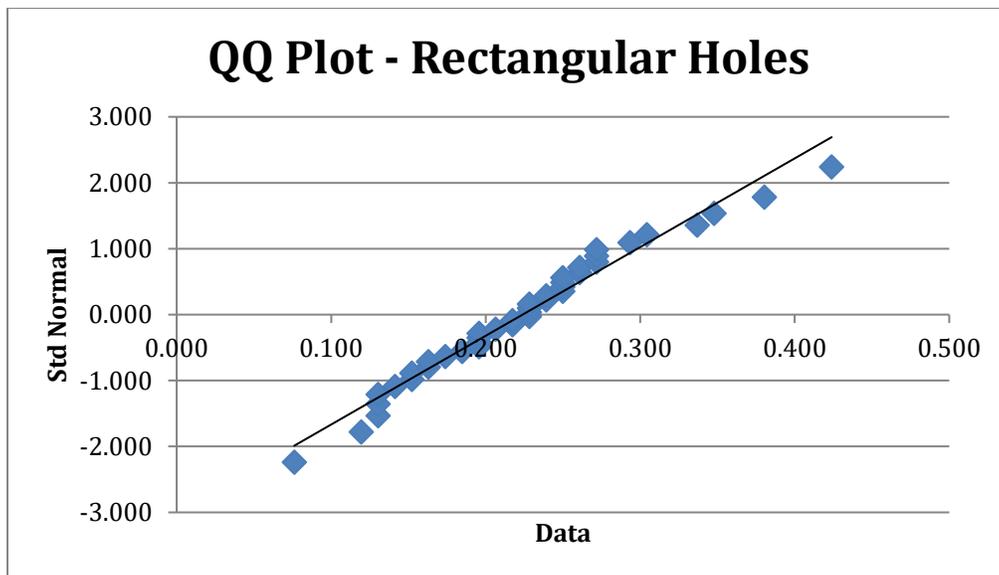
Figure 3.13: Q-Q plot of tools broken per select rows with rectangular holes. This plot implies normal behavior because of the linearity of the data.

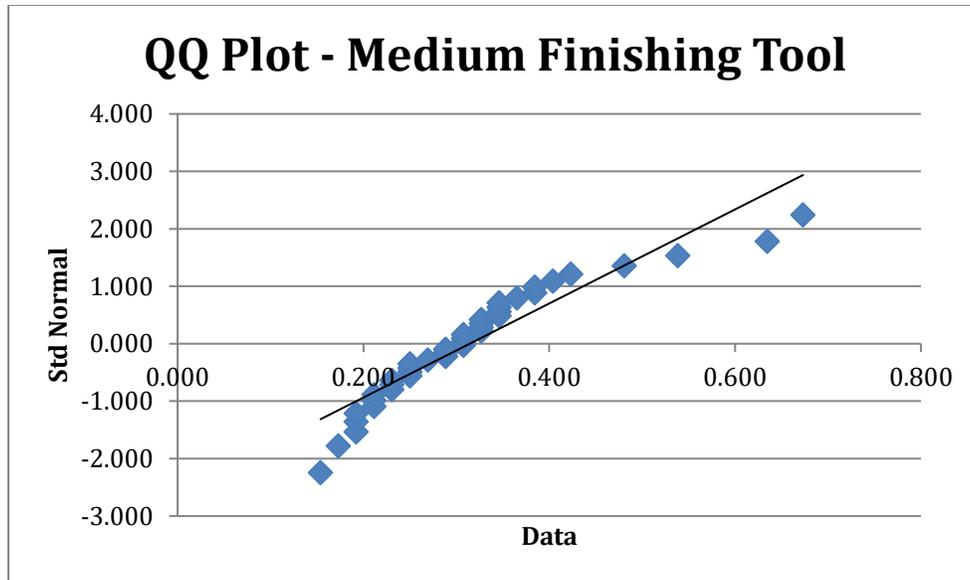
Figure 3.14: Q-Q plot of medium length tools broken per select rows with circular holes. This plot implies non-normal behavior because of the non-linearity of the data.

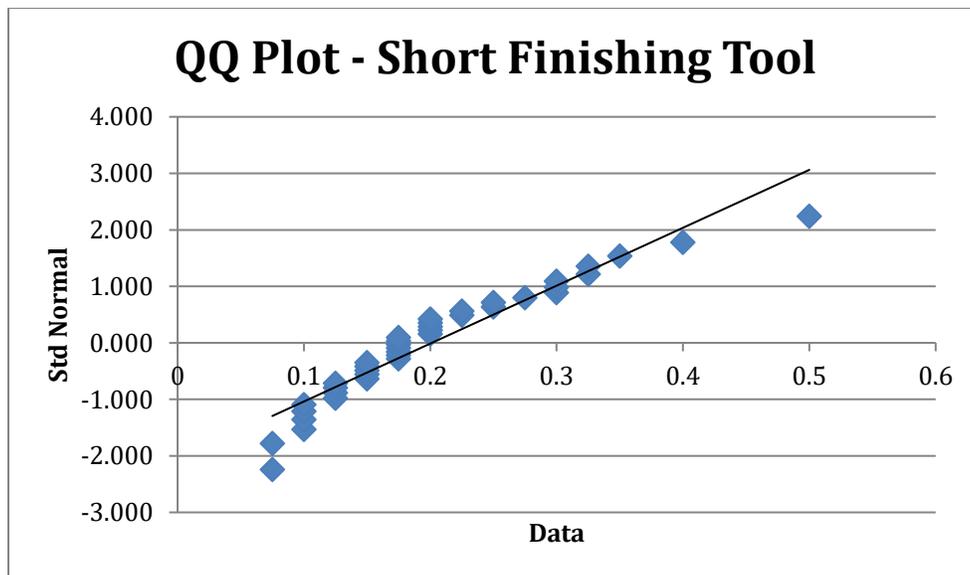
Figure 3.15: Q-Q plot of short length tools broken per select rows with circular holes. This plot implies non-normal behavior because of the non-linearity of the data.

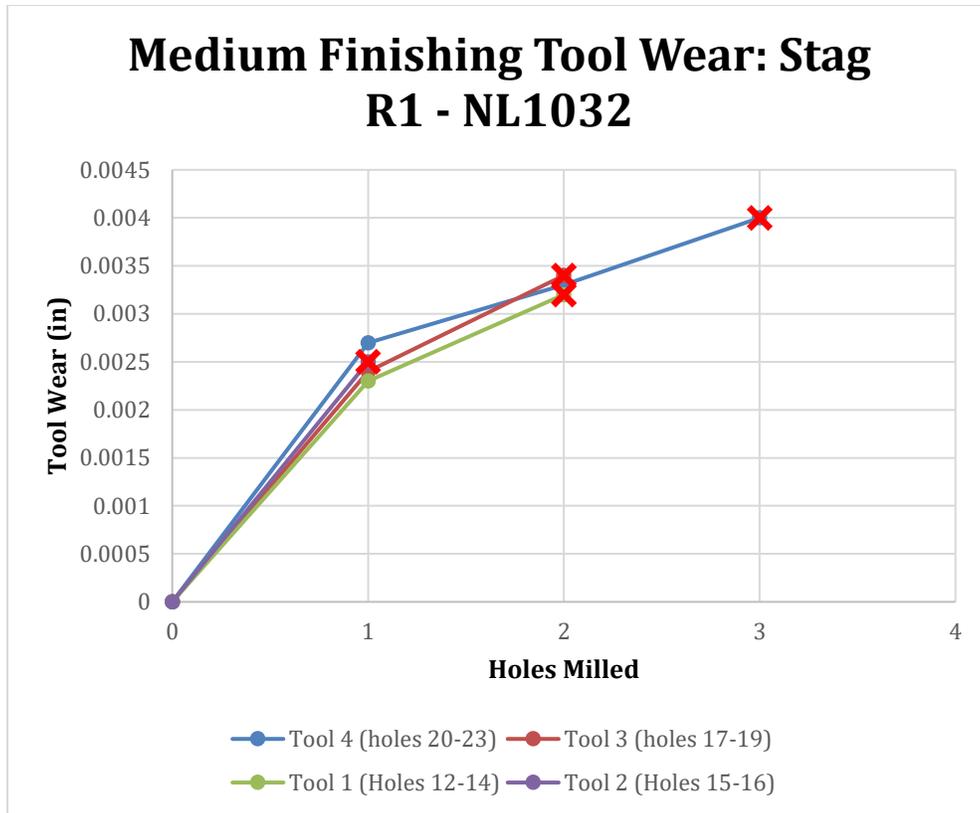
Figure 4.1: Medium length finishing tool wear plotted across holes on Stag Row 1.

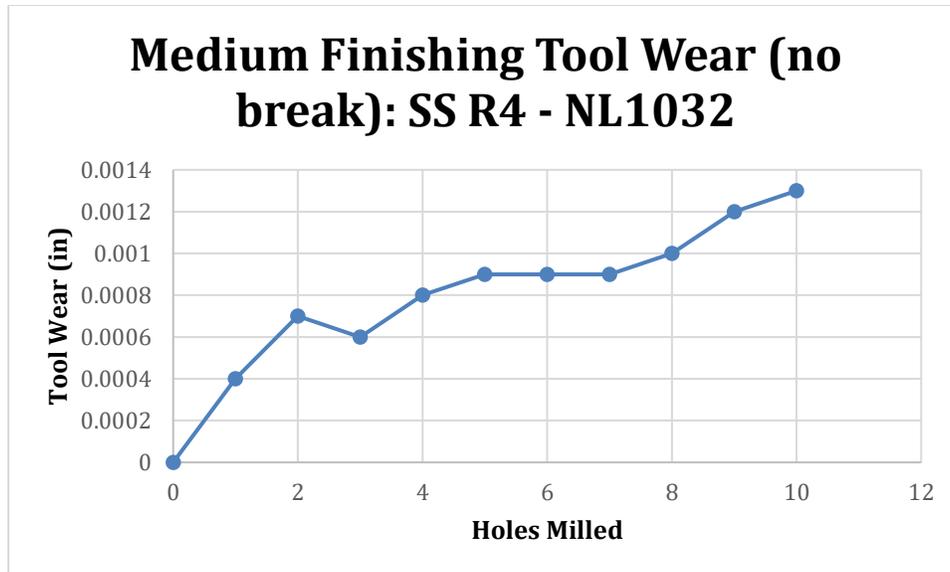
Figure 4.2: Medium length finishing tool wear plotted across holes on Suction Side Row 4. The tool used in this experiment lasted the entire row and therefore the experiment was concluded before it broke.

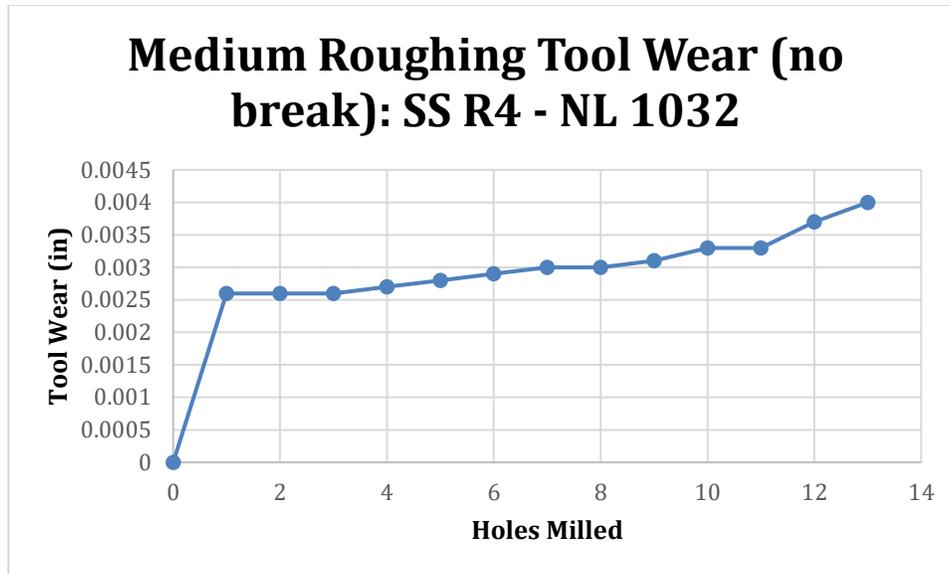
Figure 4.3: Medium length roughing tool wear plotted across holes on Suction Side Row 4. The tool used in this experiment lasted the entire row and therefore the experiment was concluded before it broke.

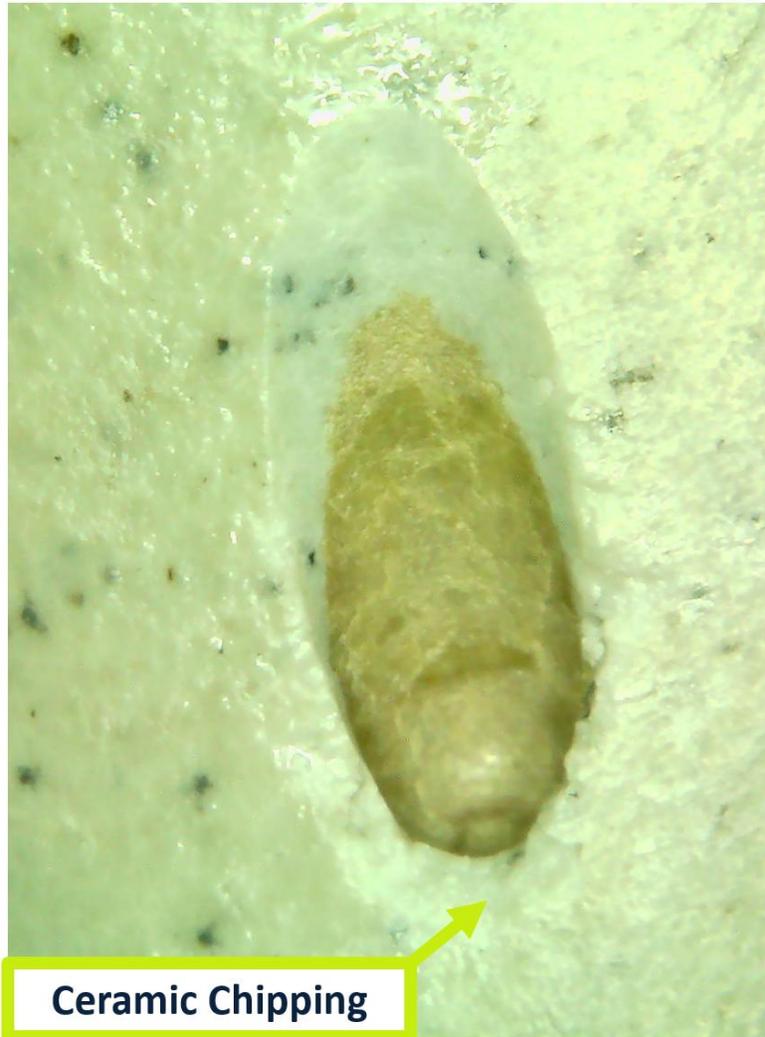
Figure 4.4: Diffuser hole on Pressure Side Row 2 after the roughing tool and before the finishing tool. Chipping from the current manufacturing process is highlighted.

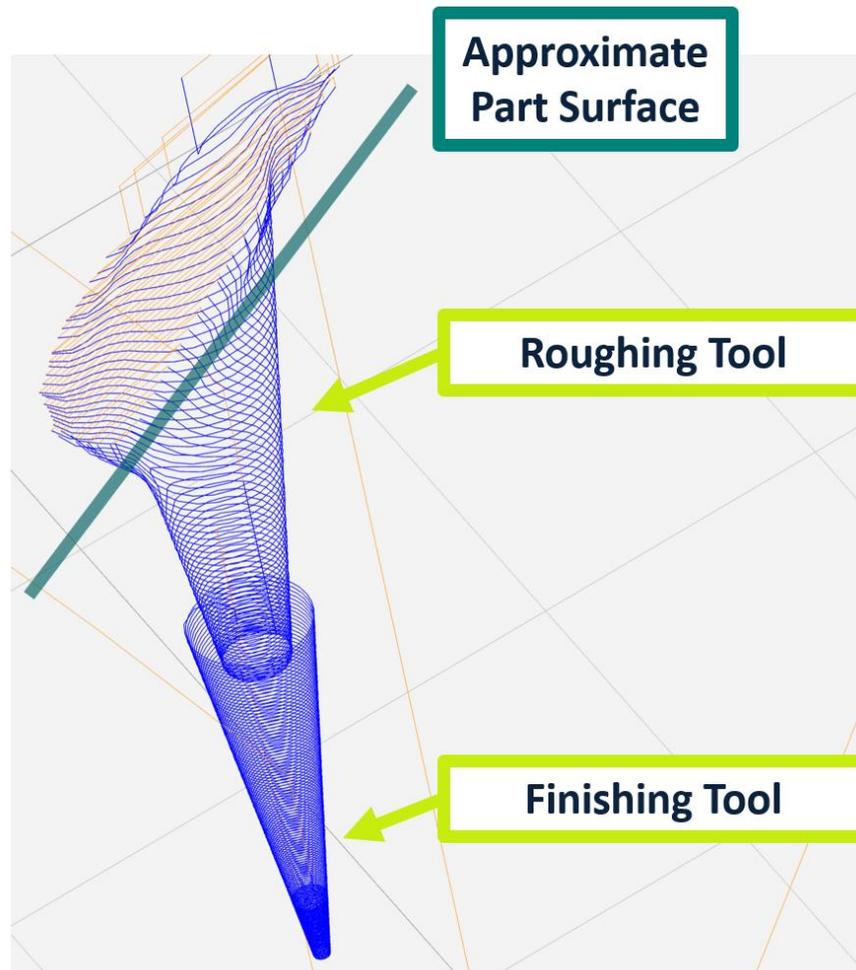
Figure 4.5: CAM toolpath of a hole on Pressure Side Row 2. A helical toolpath is shown for the roughing tool and another for the finishing tool. The tip of the tool follows the blue path.

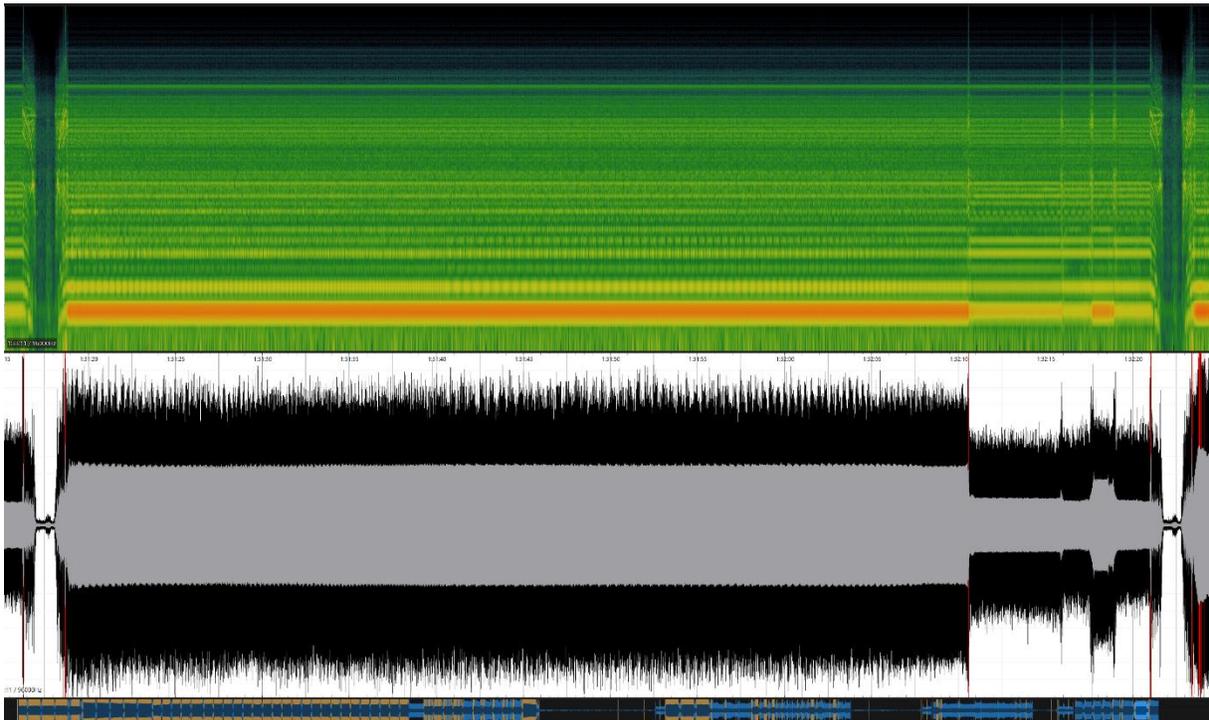
Figure 4.6: Raw waveform (bottom) and spectrogram (top) of cutting noise for one hole.

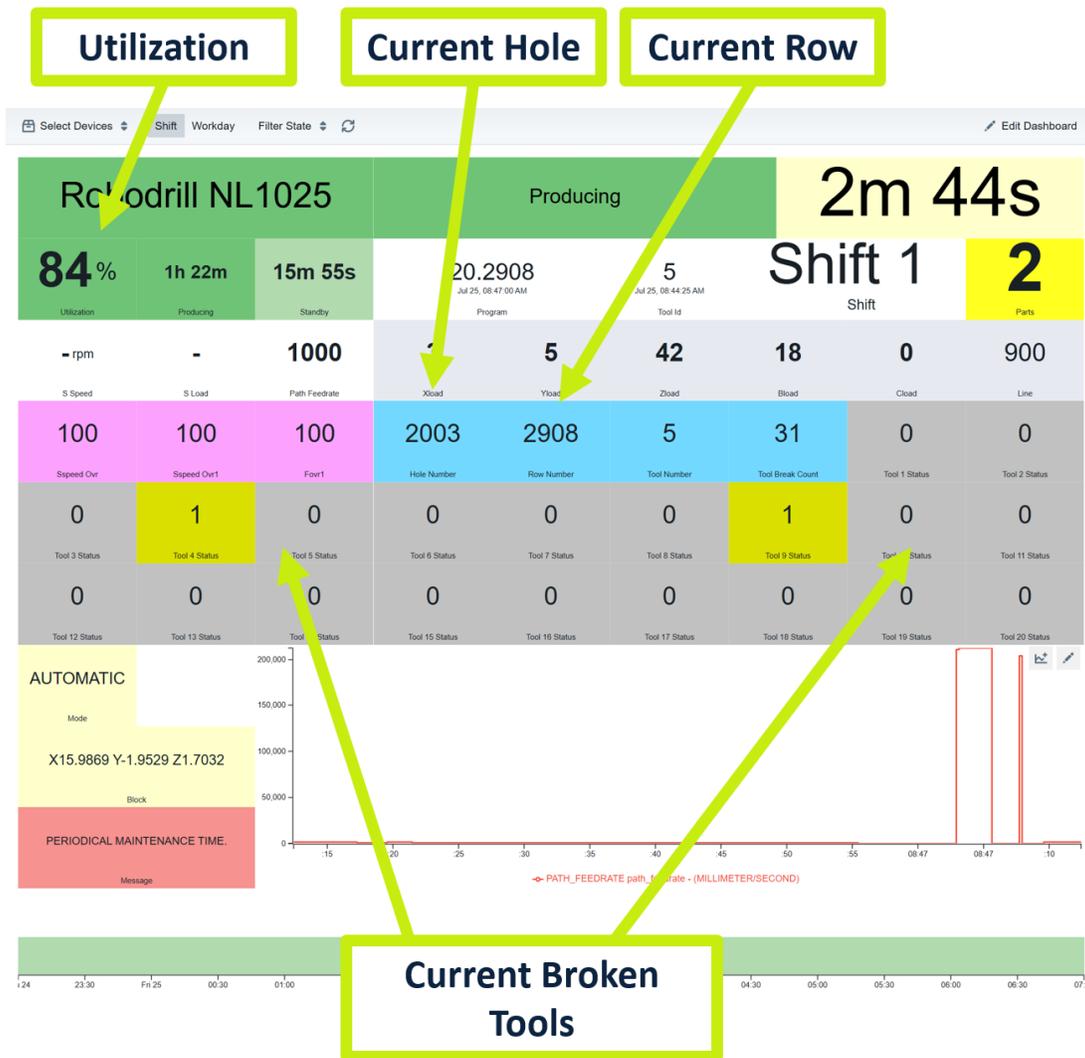
Figure 4.7: Vimana live data dashboard connected to a RoboDrill.

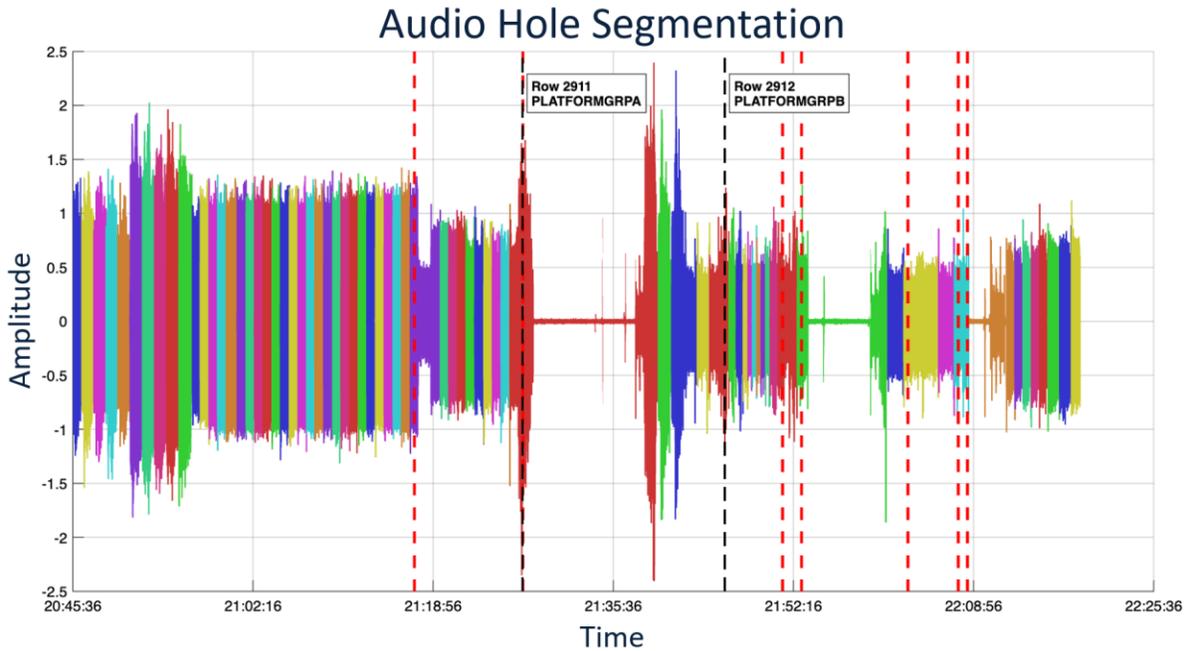
Figure 4.8: Waveform segmented into holes using Vimana data.

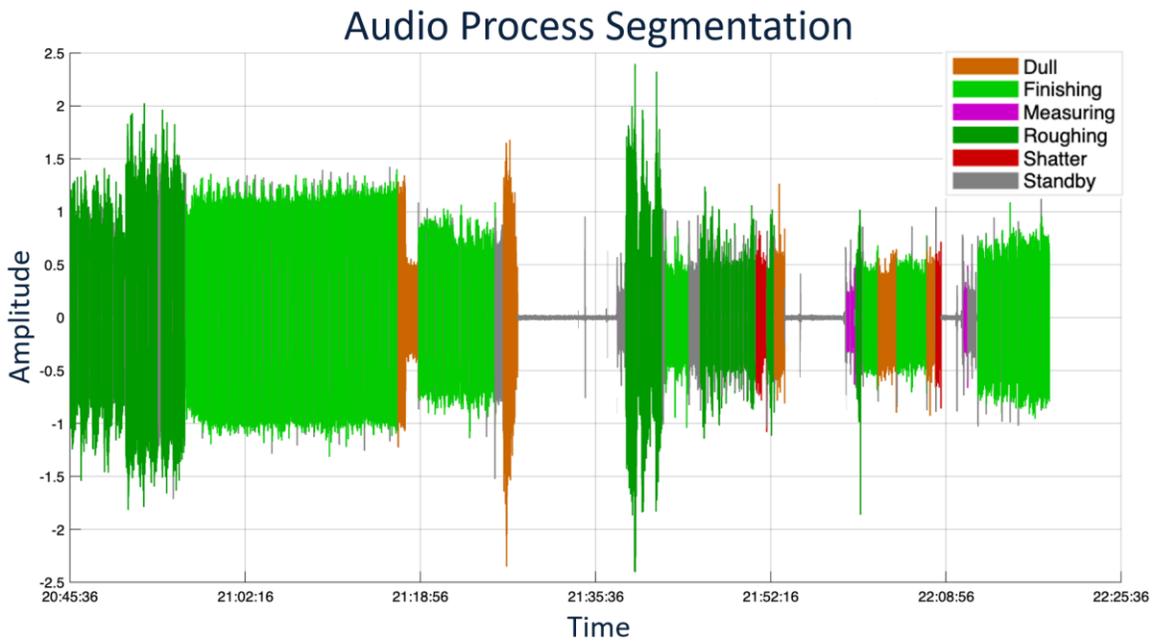
Figure 4.9: Waveform segmented into process steps using Vimana data.

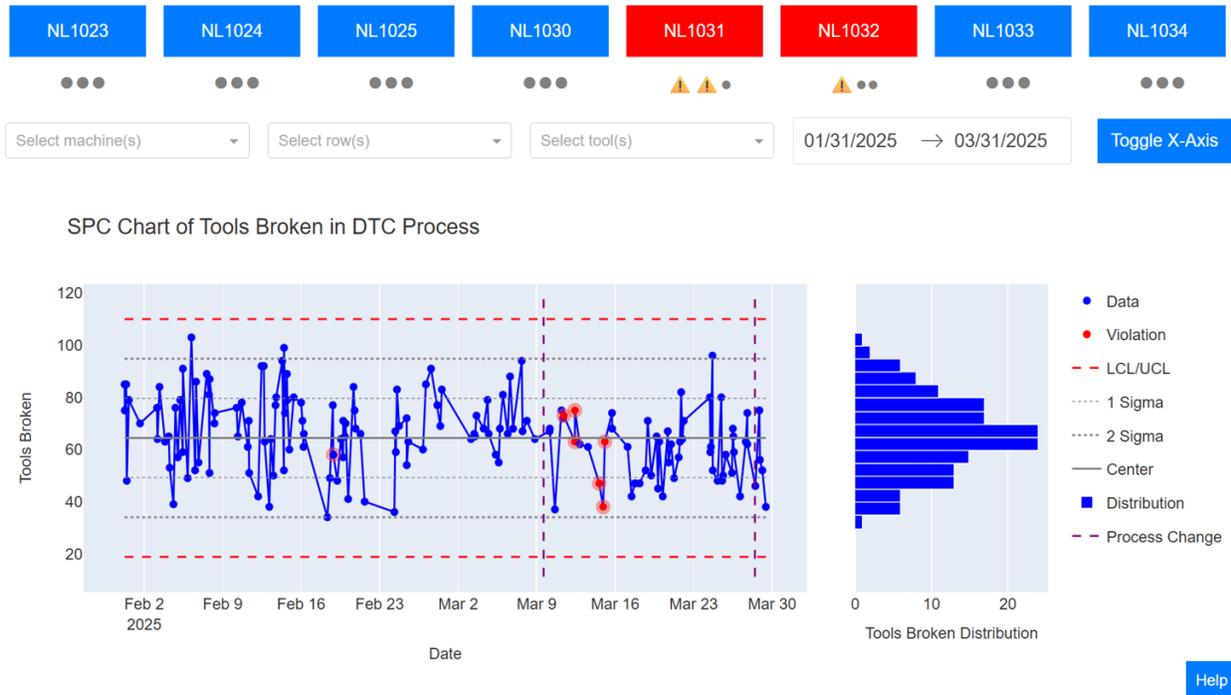
Figure 4.10: Statistical process control dashboard for tools broken during DTC process. Each data entry is the total number of tools broken on a machined part.

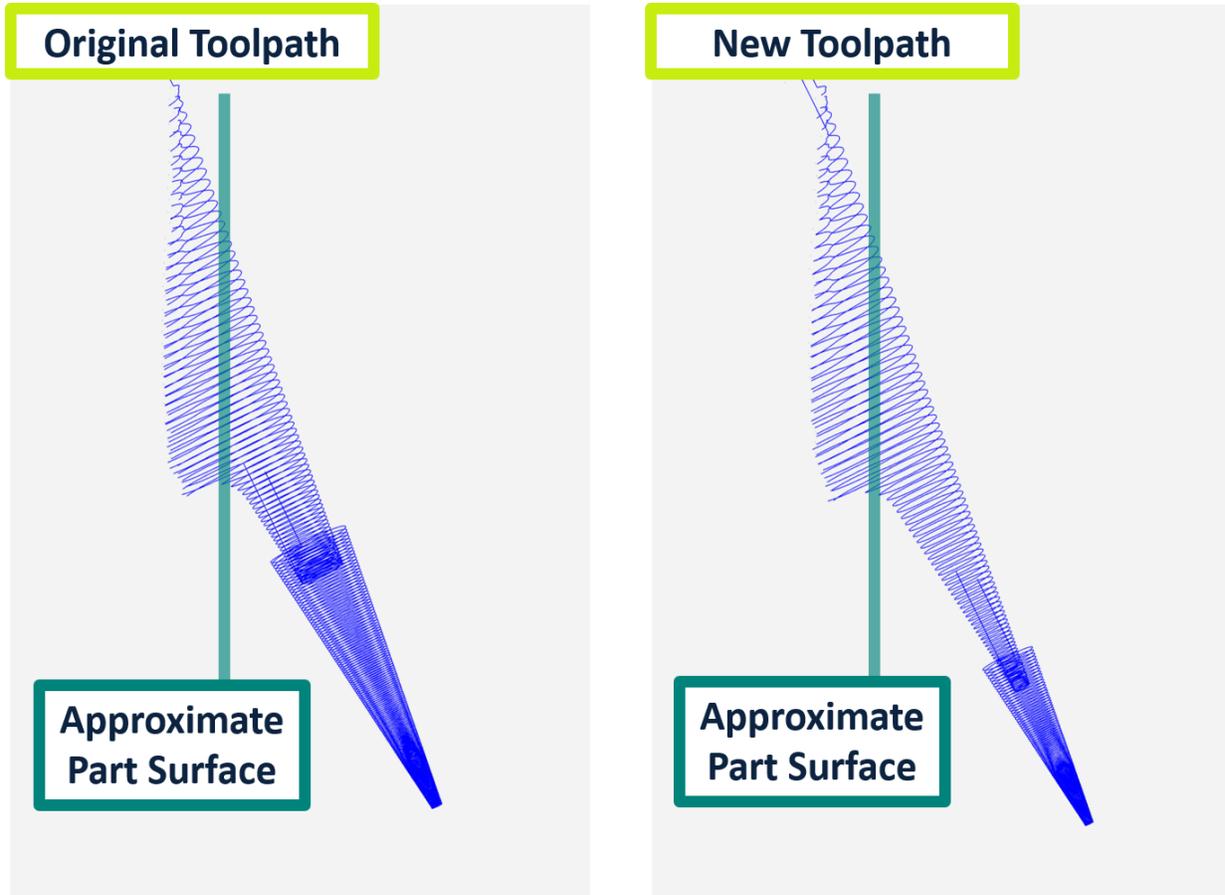
Figure 5.1: Original (left) and updated (right) CAM toolpath. This update kept the same hole geometry but extended the depth of the hole that was milled by the roughing tool.

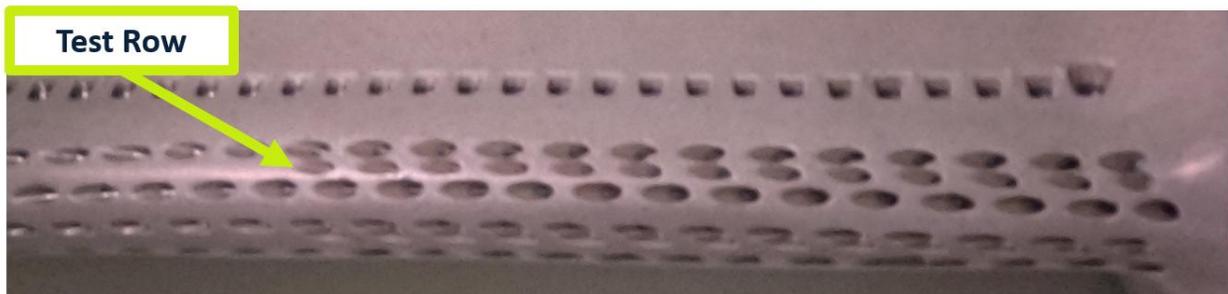
Figure 5.2: Hole offset for experiment on scrap part.

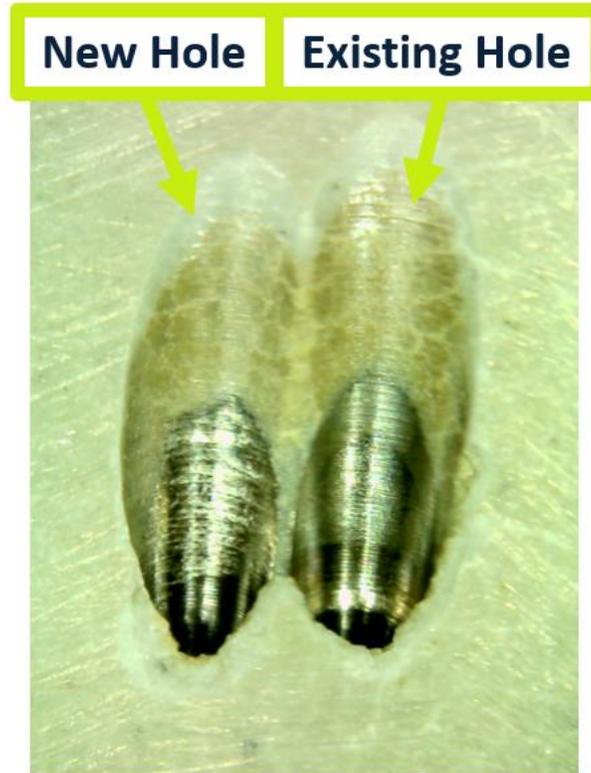
Figure 5.3: Experimental hole overlapping with existing hole.

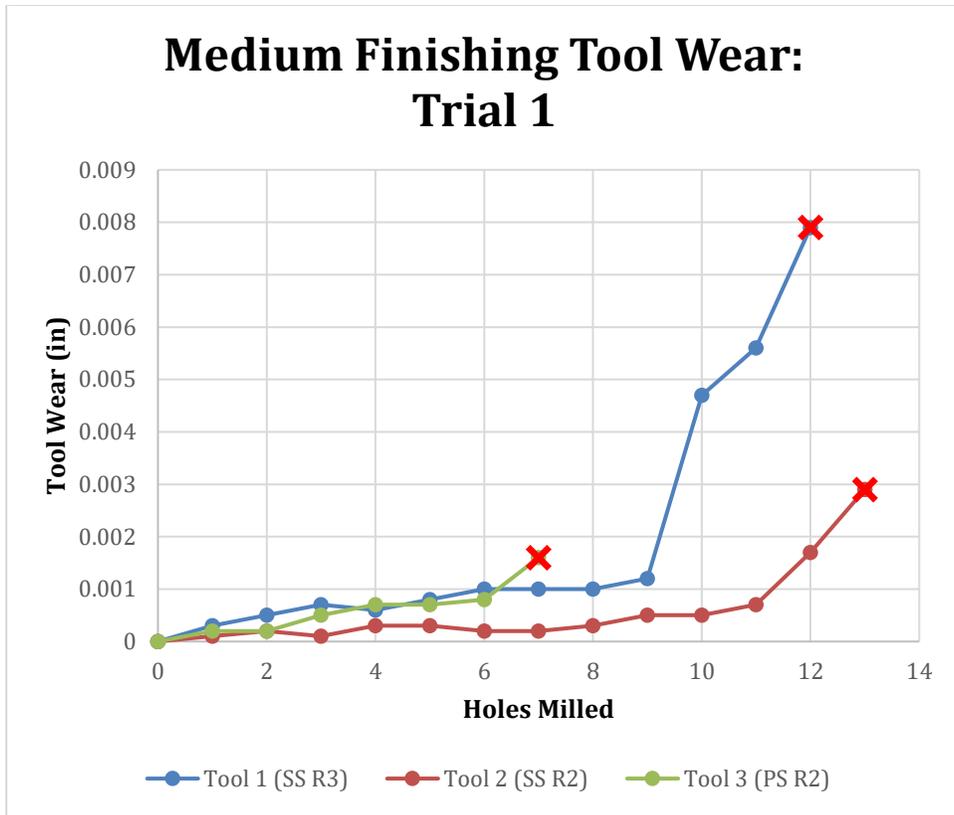
Figure 5.4: Medium length finishing tool wear plotted across holes on a scrap blade. This tool wear is significantly improved due to the updated CAM. The “X” denotes the last successful hole machined before the tool wore by 0.008 inches.

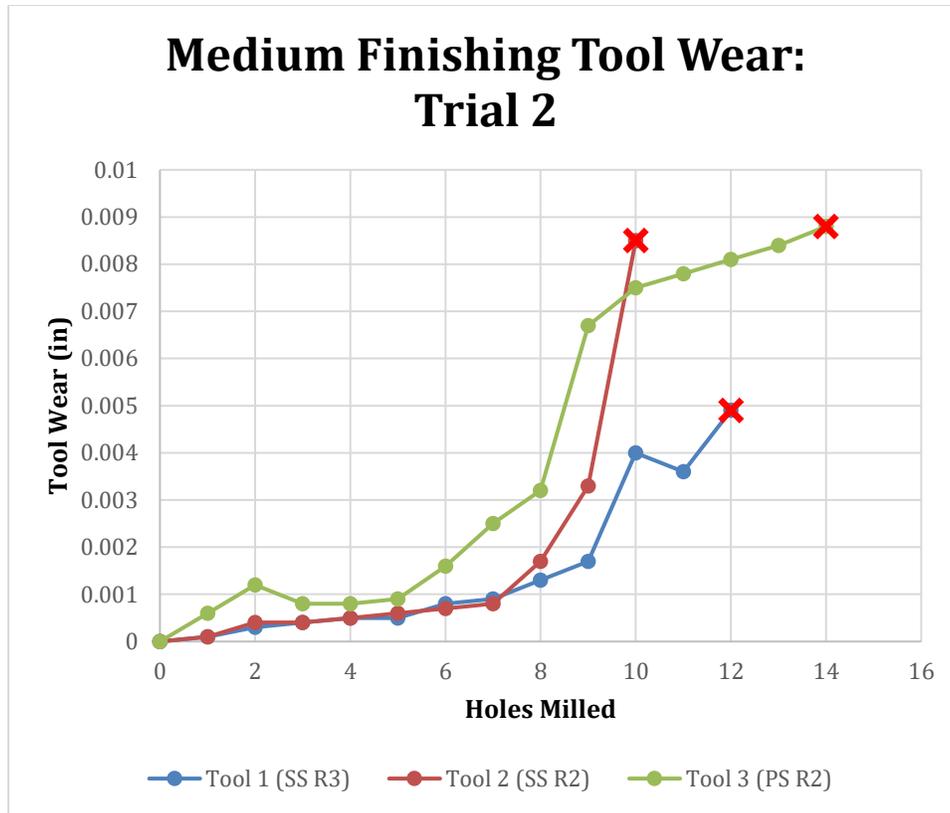
Figure 5.5: Medium length finishing tool wear plotted across holes on a second scrap blade. This tool wear is significantly improved due to the updated CAM. The “X” denotes the last successful hole machined before the tool wore by 0.008 inches.

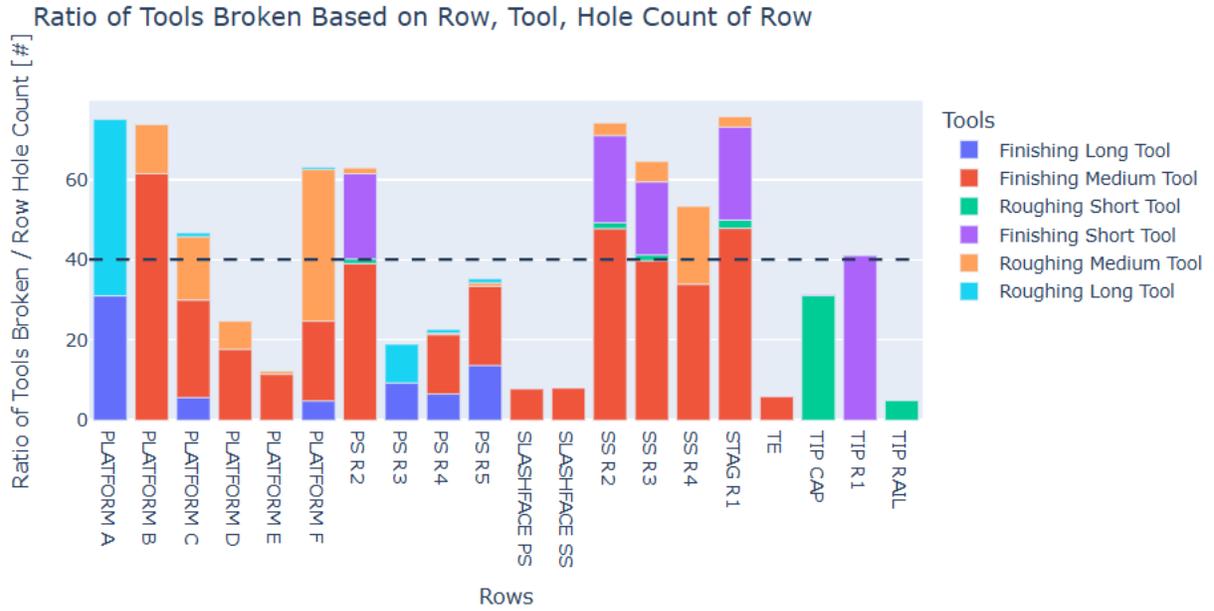
Figure B.1: Bar chart of total tool breakage by row, segmented by tool type and normalized by hole count per row.

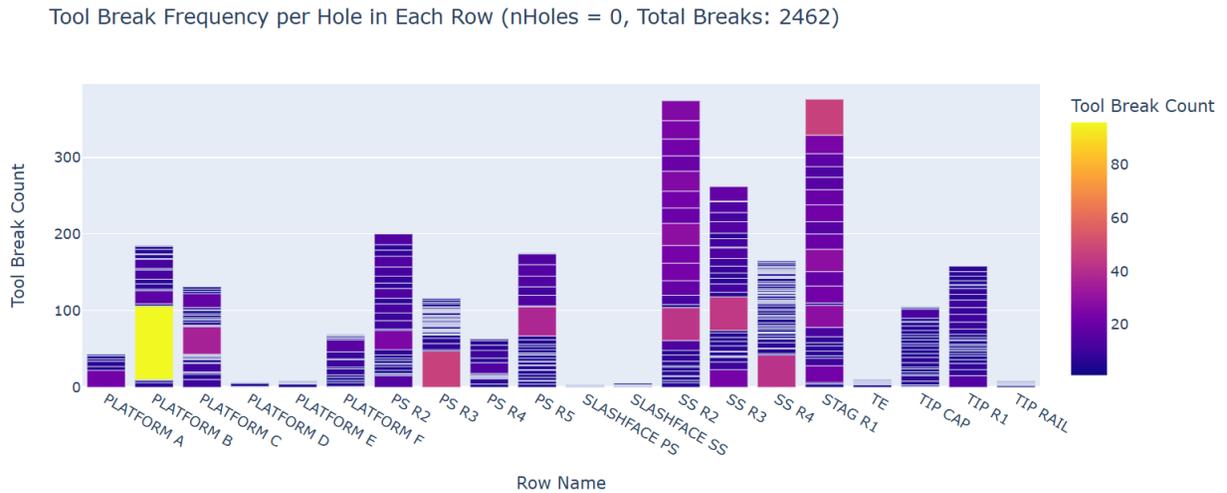
Figure B.2: Bar chart of tools broken by row with an operational life of one hole, segmented by hole.

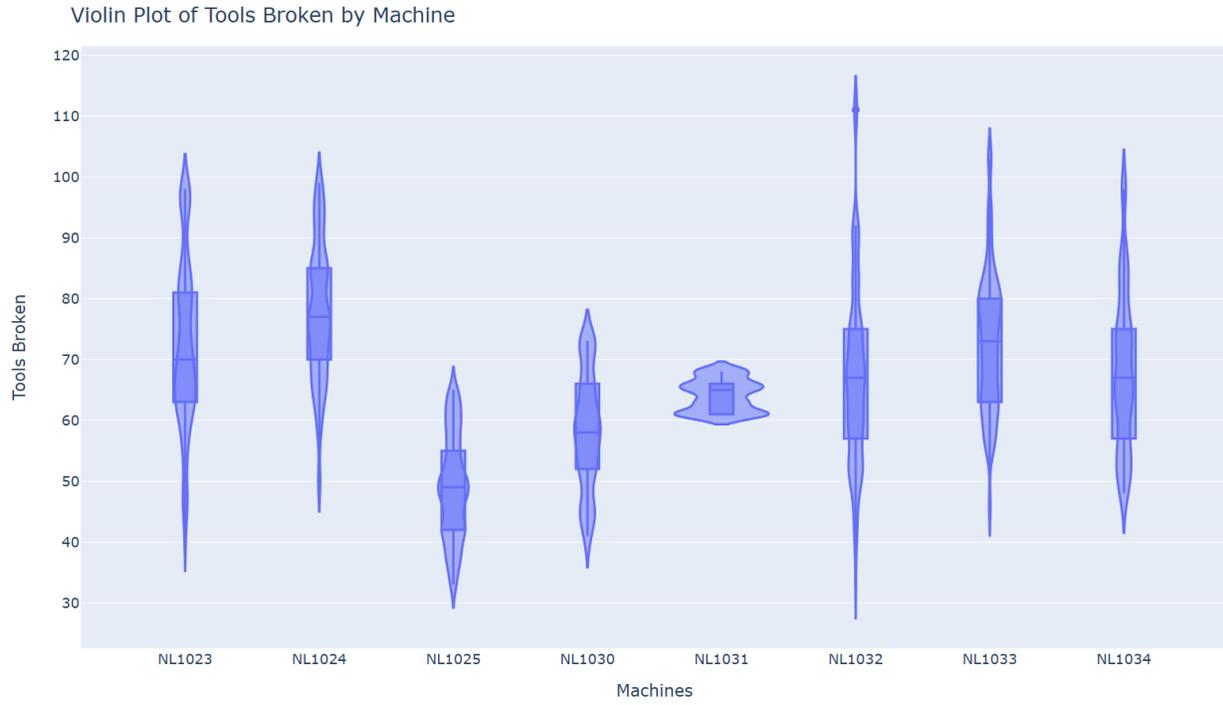
Figure B.3: Violin plot of average number of tools broken per part by each machine.

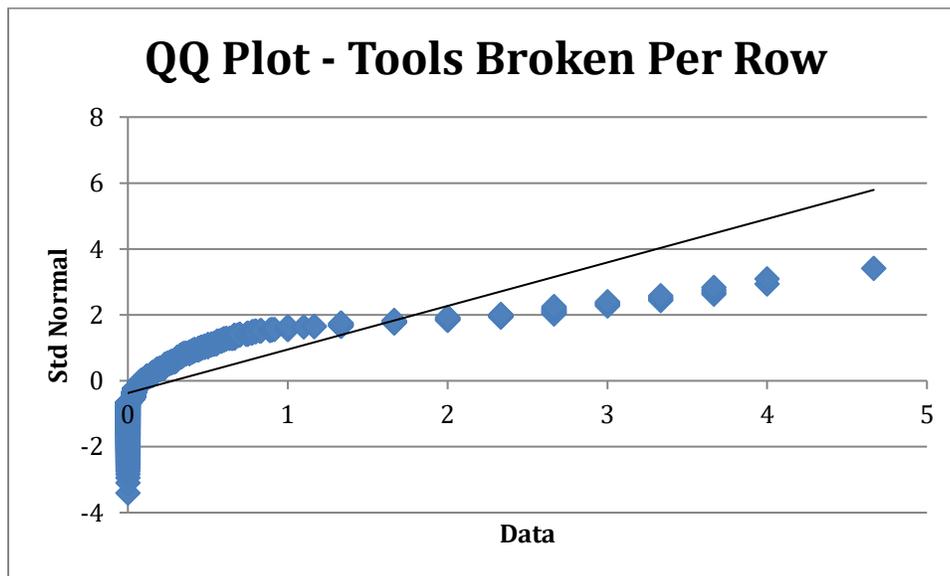
Figure C.1: Q-Q plot of tools broken per part normalized by hole count per row.
